Access Compliance Report Public Rights-of-Way (Curb Ramps)

Intersection ID: 9887 Main Street: CATALINA_AV Cross Street: CONCORDIA_AV Location: W

ADA ID: B02ACE86DCD8 Ramp Type: Directional1 Initial Pass/Fail: Fail Overall Compliance: No Severity Score: 12.5

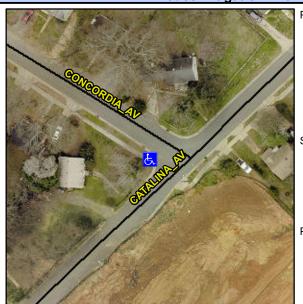
Compliance Description N/A Ramp Length (in) Yes Ramp Width (in) Yes Ramp Slope (%) No Ramp XSlope (%) N/A Flare Type LT N/A Flare Slope LT (%) N/A Flare Traversable LT? N/A Landing Length (in) N/A Landing Width (in) N/A Landing Slope (%) N/A Landing X Slope (%) N/A Landing Curb? (Y/N) N/A Shared Landing? N/A **Gutter Ponding?** N/A Gutter Lip Ht (in) N/A Painted X Walk1? X Walk 1 Direction X Walk 1 Width (in) X Walk 1 Slope (%) X Walk 1 X Slope (%) N/A Ramp inside XWalk1?

Possible Solutions:

Remove & Replace Entire Ramp.
