Access Compliance Report

Public Rights-of-Way

(Curb Ramps)

Intersection ID: 50614	Main Street: PADDLE_OAK_RD	Cross Street: BALSAM_BAY_RD	Location: NW
ADA ID: B02B9B452EE3	Ramp Type: Perp	Initial Pass/Fail: Fail	Overall Compliance: No
			Severity Score: 13.75

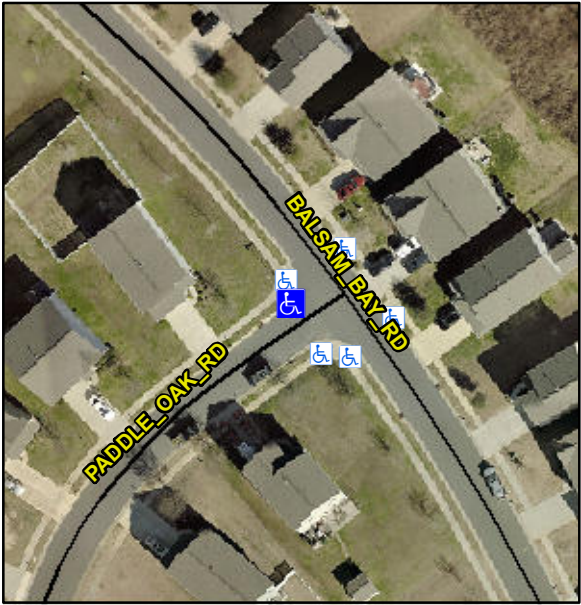
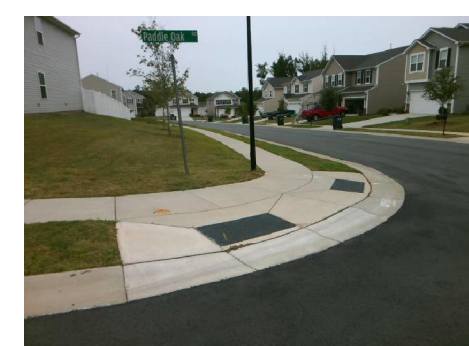
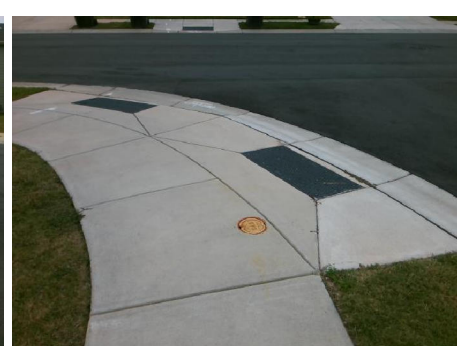
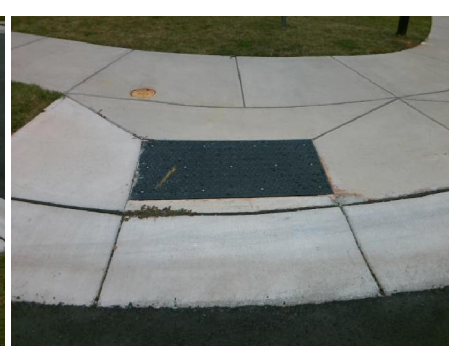
Possible Solutions:		Compliance	Description	Data
	Remove & Replace Entire Ramp.		No	Ramp Length (in)	50.0
			Yes	Ramp Width (in)	48.0
			N/A	Flare Type LT	N/A
			N/A	Flare Slope LT (%)	N/A
			N/A	Flare Traversable LT?	N/A
			N/A	Landing Length (in)	N/A
			N/A	Landing Width (in)	N/A
			N/A	Landing Slope (%)	N/A
			N/A	Landing X Slope (%)	N/A
<p>Surveyor Notes:</p> <p>N/A</p> <p>PROW/ADA:</p> <p>Not Found, R304.2.2, R304.5.3</p>			N/A	Flare Type RT	N/A
			N/A	Flare Slope RT (%)	N/A
			N/A	Flare Traversable RT?	N/A
			N/A	DWS Provided?	N/A
			N/A	DWS Contrast?	N/A
			N/A	DWS Length (in)	N/A
			N/A	DWS Full Width?	N/A
			N/A	DWS Offset (in)	N/A
			N/A	Gutter Ponding?	N/A
			N/A	Gutter Lip Ht (in)	N/A
<p>Total Cost:</p> <p>\$ 1850.00</p>			No	Painted X Walk2?	N/A
			To S	X Walk 2 Direction	N/A
			N/A	X Walk 2 Width (in)	N/A

1.8	X Walk 2 Slope (%)	N/A
			2.8	X Walk 2 X Slope (%)	N/A
			N/A	Ramp inside XWalk2?	N/A
			N/A	Clear Space?	N/A
			N/A	Clear Space to XWalk (in)	N/A
			N/A	Storm Grate/Utility Hazard?	N/A
			N/A	Storm Grate/Utility Type	N/A
			N/A	Surface Condition? (G/P)	Good
