# Access Compliance Report

## Public Rights-of-Way

### (Curb Ramps)

Intersection ID: 14086	Main Street: BALDWIN_AV	Cross Street: E_3RD_ST	Location: E
ADA ID: B02BB0EAF15B	Ramp Type: Perp	Initial Pass/Fail: Fail	Overall Compliance: No
Severity Score: 21.25			
Codes/Mitigation Info/Possible Solution		Field Measurements/Component Compliance

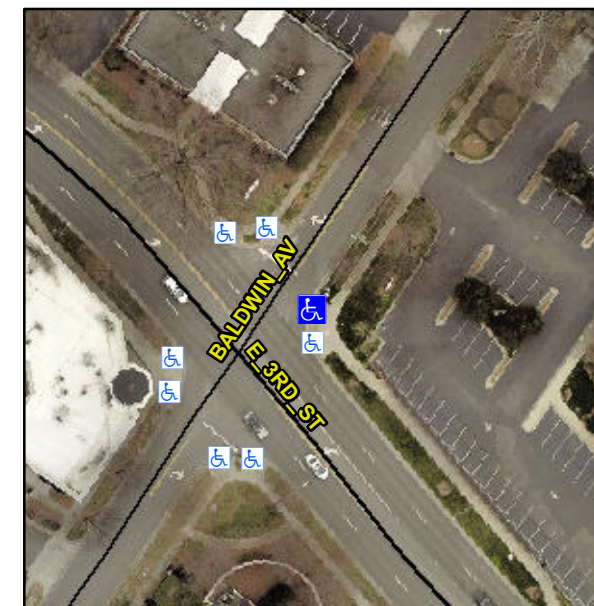
**Not Found, R304.5.1, R304.5.3**

Compliance	Description	Data	Compliance	Description	Data
N/A	Ramp Length (in)	93.0	Yes	Ramp Slope (%)	6.9
No	Ramp Width (in)	36.0	No	Ramp XSlope (%)	5.1
N/A	Flare Type LT	N/A	N/A	Flare Type RT	N/A
N/A	Flare Slope LT (%)	N/A	N/A	Flare Slope RT (%)	N/A
N/A	Flare Traversable LT?	N/A	N/A	Flare Traversable RT?	N/A
N/A	Landing Length (in)	N/A	N/A	DWS Provided?	N/A
N/A	Landing Width (in)	N/A	N/A	DWS Contrast?	N/A
N/A	Landing Slope (%)	N/A	N/A	DWS Length (in)	N/A
N/A	Landing X Slope (%)	N/A	N/A	DWS Full Width?	N/A
N/A	Landing Curb? (Y/N)	N/A	N/A	DWS Offset (in)	N/A
N/A	Shared Landing?	N/A			
N/A	Gutter Ponding?	N/A	N/A	Gutter Slope (%)	N/A
N/A	Gutter Lip Ht (in)	N/A	N/A	Gutter X Slope (%)	N/A
N/A	Painted X Walk1?	No	N/A	Painted X Walk2?	N/A
	X Walk 1 Direction	To NW		X Walk 2 Direction	N/A
N/A	X Walk 1 Width (in)	N/A	N/A	X Walk 2 Width (in)	N/A
	X Walk 1 Slope (%)	2.6		X Walk 2 Slope (%)	N/A
	X Walk 1 X Slope (%)	2.9		X Walk 2 X Slope (%)	N/A

N/A	Ramp inside XWalk1?	N/A	N/A	Ramp inside XWalk2?	N/A
	Road Slope (%)	N/A	N/A	Clear Space?	N/A
	Road X Slope (%)	N/A	N/A	Clear Space to XWalk (in)	N/A
N/A	Any Obstructions?	N/A	N/A	Storm Grate/Utility Hazard?	N/A
	Obstruction Type			Storm Grate/Utility Type	
		N/A			N/A
		Yes		Surface Condition? (G/P)	Good

Possible Solutions:

**Remove & Replace Entire Ramp.**
