Access Compliance Report

Public Rights-of-Way

(Curb Ramps)

| Intersection ID: 18818 | Main Street: BEAM_RD | Cross Street: SHOPTON_RD | Location: NW |

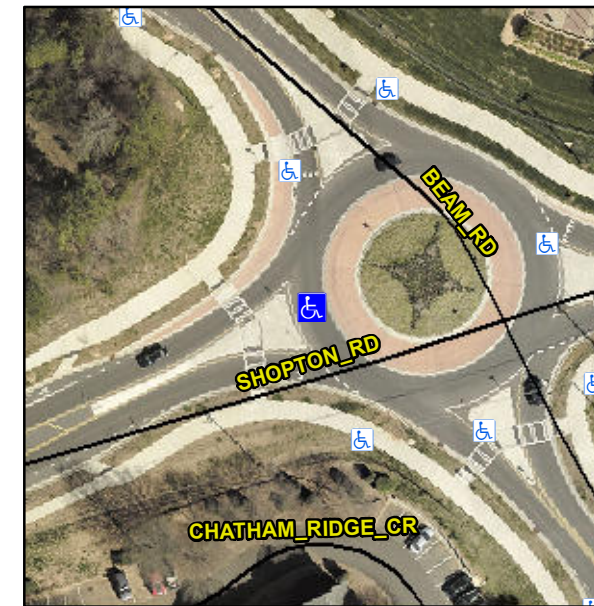
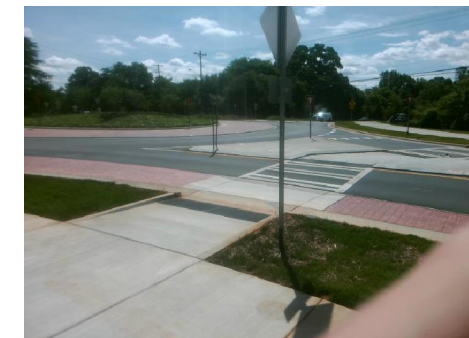
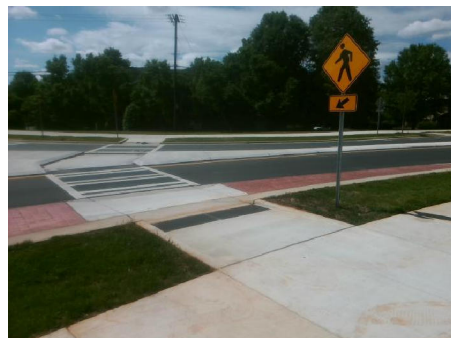
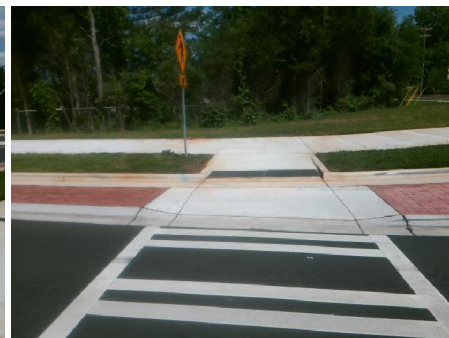
| ADA ID: B05B1A2E07A2 | Ramp Type: Perp | Initial Pass/Fail: Fail | Overall Compliance: No |
| | | Severity Score: 12.5 | |

| Compliance | Description | Data | Compliance | Description | Data |
|---|---|---|---|---|---|
| N/A | Ramp Length (in) | 190.0 | Yes | Ramp Slope (%) | 9.7 |
| Yes | Ramp Width (in) | 97.0 | Yes | Ramp XSlope (%) | 1.3 |

Possible Solutions:

Remove & Replace Entire Ramp.

Total Cost:

\$ 1850.00
