Access Compliance Report

Public Rights-of-Way

(Curb Ramps)

Intersection ID: 14734	Main Street: DILWORTH_RD_WEST	Cross Street: ISLEWORTH_AV	Location:	S
ADA ID: B05CA9810E56	Ramp Type: Directional1	Initial Pass/Fail: Fail	Overall Compliance: No	Severity Score: 12.5
Codes/Mitigation Info/Possible Solution		Field Measurements/Component Compliance

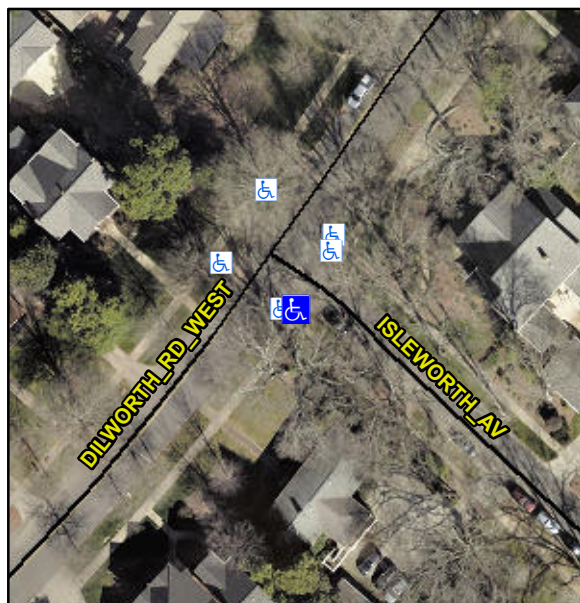
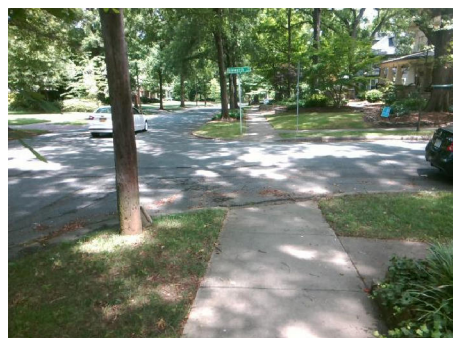
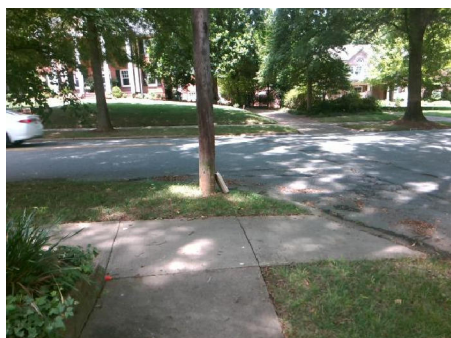
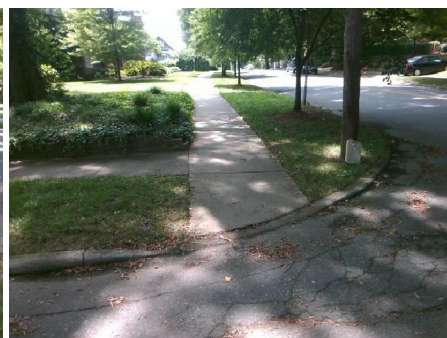
Compliance	Description	Data	Compliance	Description	Data
N/A	Ramp Length (in)	48.0	N/A	Grade Break?	N/A
Yes	Ramp Width (in)	58.0	N/A	Grade Break Slope (%)	0.0
No	Ramp Slope (%)	9.7	N/A	Grade Break XSlope (%)	0.0
Yes	Ramp XSlope (%)	0.2			
N/A	Flare Type LT	N/A	N/A	Flare Type RT	N/A
N/A	Flare Slope LT (%)	N/A	N/A	Flare Slope RT (%)	0.0
N/A	Flare Traversable LT?	N/A	N/A	Flare Traversable RT?	N/A
N/A	Landing Length (in)	0.0	N/A	DWS Provided?	N/A
N/A	Landing Width (in)	0.0	N/A	DWS Contrast?	N/A
N/A	Landing Slope (%)	0.0	N/A	DWS Length (in)	N/A
N/A	Landing X Slope (%)	0.0	N/A	DWS Full Width?	N/A
N/A	Landing Curb? (Y/N)	N/A	N/A	DWS Offset LT (in)	N/A
N/A	Shared Landing?	N/A	N/A	DWS Offset RT (in)	N/A
N/A	Gutter Ponding?	0.0	N/A	Gutter Slope (%)	N/A
N/A	Gutter Lip Ht (in)	1.0	N/A	Gutter X Slope (%)	N/A
N/A	Painted X Walk1?	No		Road Slope (%)	0.6
	X Walk 1 Direction	To NE		Road X Slope (%)	0.5
	X Walk 1 Width (in)	N/A		Clear Space?	N/A

X Walk 1 Slope (%)	0.6	N/A	Clear Space to XWalk (in)	N/A
	X Walk 1 X Slope (%)	0.5	N/A	Storm Grate/Utility Hazard?	N/A
N/A	Ramp inside XWalk1?	N/A		Storm Grate/Utility Type	
N/A	Any Obstructions?	N/A			N/A
	Obstruction Type		Yes	Surface Condition? (G/P)	Good
			N/A	Curb Slope (%)	1.9

Remove & Replace Entire Ramp.

Total Cost: \$ 1600.00
