Access Compliance Report Public Rights-of-Way (Curb Ramps)

Intersection ID: 44933	Main Str	Main Street: ACORN_FOREST_LN			Cross Street: BRUMIT_LN				W	
ADA ID: B0601E4FF0DD	Ramp Ty	Ramp Type: PerpDiag			nitial Pass/Fail: Fail Overall Compliance: No				33.75	
Codes/Mitigation Info/Possible Solution					al Pass/Fail: Fail Overall Compliance: No Severity Score: 33.75 Field Measurements/Component Compliance					
		Possible Solutions:					Comp	Data		
C'ART		Remove & Replace Curb Ramp	With	N/A	Ramp Length (in)	49.0	No	Ramp Slope (%)	9.0	
		Two New Directional Ramps or		No	Ramp Width (in)	38.5	No	Ramp XSlope (%)	5.2	
		Equivalent.		N/A	Flare Type LT	N/A	N/A	Flare Type RT	N/A	
				N/A	Flare Slope LT (%)	N/A	N/A	Flare Slope RT (%)	N/A	
SECONDE AS				N/A	Flare Traversable LT?	N/A	N/A	Flare Traversable RT?	N/A	
A A A A A A A A A A A A A A A A A A A	3			N/A	Landing Length (in)	N/A	N/A	DWS Provided?	N/A	
	The second	Surveyor Notes:		N/A	Landing Width (in)	N/A	N/A	DWS Contrast?	N/A

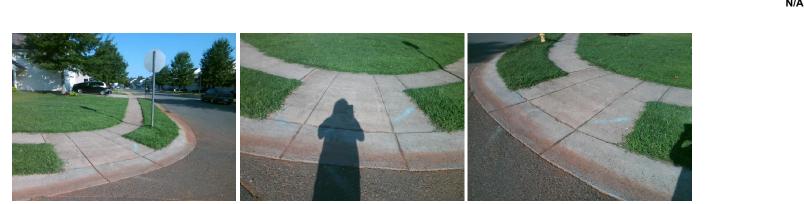
E. OT	G.	N/A		N/A	Landing Slope (%)	N/A	N/A	DWS Length (in)	N/A	
	A CAN			N/A	Landing X Slope (%)	N/A	N/A	DWS Full Width?	N/A	
				N/A	Landing Curb? (Y/N)	N/A	N/A	DWS Offset (in)	N/A	
				N/A	Shared Landing?	N/A				
		PROW/ADA:		N/A	Gutter Ponding?	Yes	N/A	Gutter Slope (%)	N/A	
		R304.5.1, R304.2.2, R304.5.3		N/A	Gutter Lip Ht (in)	N/A	N/A	Gutter X Slope (%)	N/A	
	,,		N/A	Painted X Walk1?	No	N/A	Painted X Walk2?	No		
					X Walk 1 Direction	To SE		X Walk 2 Direction	To NE	
				N/A	X Walk 1 Width (in)	N/A	N/A	X Walk 2 Width (in)	N/A	
Street 1 Name A	CORN FOREST LN				X Walk 1 Slope (%)	0.0		X Walk 2 Slope (%)	8.1	
Stop Condition-Street 2	None				X Walk 1 X Slope (%)	9.6		X Walk 2 X Slope (%)	2.1	
Street 2 Name	BRUMIT LN			N/A	Ramp inside XWalk1?	N/A	N/A	Ramp inside XWalk2?	N/A	
Stop Condition-Street 1	StopSign				Road Slope (%)	8.8	N/A	Clear Space?	N/A	
					Road X Slope (%)	5.4	N/A	Clear Space to XWalk (in)	N/A

N/A	Any Obstructions?	N/A	N/A	Storm Grate/Utility Hazard?	N/A	
		Total Cost: \$	3200.00		Obstruction Type			Storm Grate/Utility Type		
						N/A			N/A
