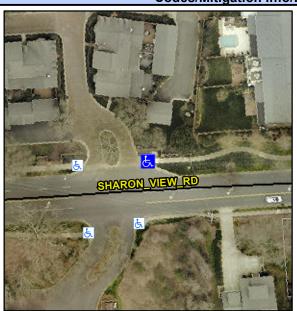
3200.00

Field Measurements/Component Compliance						
Compliance Description		Data	Comp	liance Description	Data	
N/A	Ramp Length (in)	45.0	No	Ramp Slope (%)	8.8	
Yes	Ramp Width (in)	48.0	No	Ramp XSlope (%)	3.9	
N/A	Flare Type LT	N/A	N/A	Flare Type RT	N/A	
N/A	Flare Slope LT (%)	N/A	N/A	Flare Slope RT (%)	N/A	
N/A	Flare Traversable LT?	N/A	N/A	Flare Traversable RT?	N/A	
N/A	Landing Length (in)	N/A	N/A	DWS Provided?	N/A	
N/A	Landing Width (in)	N/A	N/A	DWS Contrast?	N/A	
N/A	Landing Slope (%)	N/A	N/A	DWS Length (in)	N/A	
N/A	Landing X Slope (%)	N/A	N/A	DWS Full Width?	N/A	
N/A	Landing Curb? (Y/N)	N/A	N/A	DWS Offset (in)	N/A	
N/A	Shared Landing?	N/A				
N/A	Gutter Ponding?	N/A	N/A	Gutter Slope (%)	N/A	
N/A	Gutter Lip Ht (in)	N/A	N/A	Gutter X Slope (%)	N/A	
N/A	Painted X Walk1?	No	N/A	Painted X Walk2?	No	
	X Walk 1 Direction	To W		X Walk 2 Direction	To SW	
N/A	X Walk 1 Width (in)	N/A	N/A	X Walk 2 Width (in)	N/A	
	X Walk 1 Slope (%)	0.2		X Walk 2 Slope (%)	2.1

ENTRANCE Street 1 Name Stop Condition-Street 2 None Street 2 Name **SHARON VIEW RD** Stop Condition-Street 1 None
