Access Compliance Report

Public Rights-of-Way

(Curb Ramps)

| Intersection ID: 10020374 | Main Street: BALLANTYNE CORPORATE PL | Cross Street: N/A | Location: S |

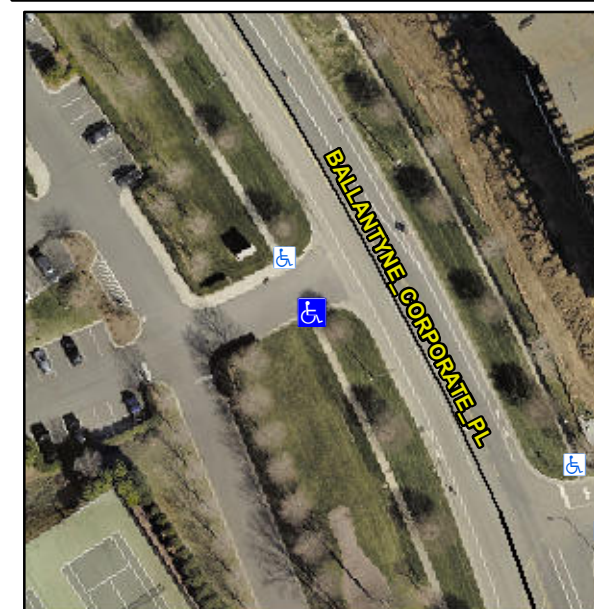
| ADA ID: B06FFA94836A | Ramp Type: Perp | Initial Pass/Fail: Fail | Overall Compliance: No |

Not Found, R304.5.1, R304.2.2, R304.5.3

| Compliance | Description | Data | Compliance | Description | Data |
|---|---|---|---|---|---|
| N/A | Ramp Length (in) | 71.0 | No | Ramp Slope (%) | 14.9 |
| No | Ramp Width (in) | 47.0 | No | Ramp XSlope (%) | 2.6 |

Remove & Replace Entire Ramp.
