Access Compliance Report

Public Rights-of-Way

(Curb Ramps)

Intersection ID: 28101	Main Street: OLYMPIC CLUB DR	Cross Street: PINE VALLEY CLUB DR	Location: SW
ADA ID: B071AB3B8D8A	Ramp Type: PerpDiag	Initial Pass/Fail: Fail	Overall Compliance: No
Codes/Mitigation Info/Possible Solution			Severity Score: 25
			Field Measurements/Component Compliance

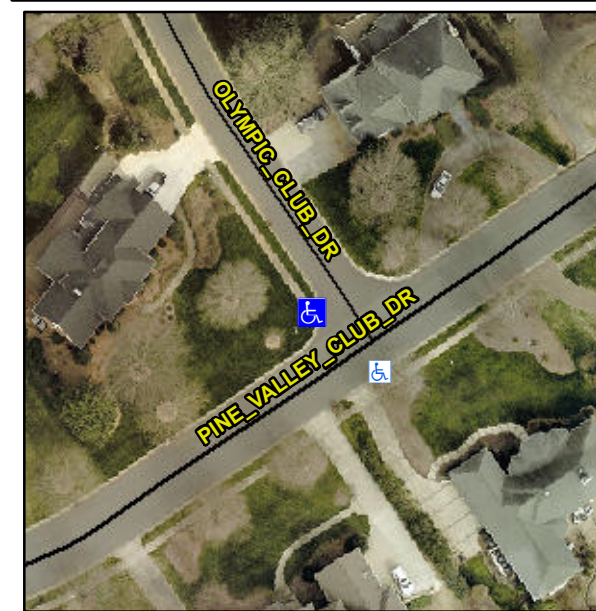
Not Found, R304.2.2, R304.5.3

Compliance	Description	Data	Compliance	Description	Data
N/A	Ramp Length (in)	46.0	No	Ramp Slope (%)	11.1
Yes	Ramp Width (in)	48.0	No	Ramp XSlope (%)	5.6
N/A	Flare Type LT	N/A	N/A	Flare Type RT	N/A
N/A	Flare Slope LT (%)	N/A	N/A	Flare Slope RT (%)	N/A
N/A	Flare Traversable LT?	N/A	N/A	Flare Traversable RT?	N/A
N/A	Landing Length (in)	N/A	N/A	DWS Provided?	N/A
N/A	Landing Width (in)	N/A	N/A	DWS Contrast?	N/A
N/A	Landing Slope (%)	N/A	N/A	DWS Length (in)	N/A
N/A	Landing X Slope (%)	N/A	N/A	DWS Full Width?	N/A
N/A	Landing Curb? (Y/N)	N/A	N/A	DWS Offset (in)	N/A
N/A	Shared Landing?	N/A			
N/A	Gutter Ponding?	N/A	N/A	Gutter Slope (%)	N/A
N/A	Gutter Lip Ht (in)	N/A	N/A	Gutter X Slope (%)	N/A
N/A	Painted X Walk1?	No	N/A	Painted X Walk2?	No
	X Walk 1 Direction	To SE		X Walk 2 Direction	To NE
N/A	X Walk 1 Width (in)	N/A	N/A	X Walk 2 Width (in)	N/A
	X Walk 1 Slope (%)	2.4		X Walk 2 Slope (%)	1.3
	X Walk 1 X Slope (%)	2.6		X Walk 2 X Slope (%)	2.1

N/A	Ramp inside XWalk1?	N/A	N/A	Ramp inside XWalk2?	N/A
	Road Slope (%)	2.9	N/A	Clear Space?	N/A
	Road X Slope (%)	1.7	N/A	Clear Space to XWalk (in)	N/A
N/A	Any Obstructions?	N/A	N/A	Storm Grate/Utility Hazard?	N/A
	Obstruction Type			Storm Grate/Utility Type	
		N/A			N/A
			Yes	Surface Condition? (G/P)	Good

Possible Solutions:

Remove & Replace Curb Ramp With Two New Directional Ramps or Equivalent.
