Access Compliance Report

Public Rights-of-Way

(Curb Ramps)

| Intersection ID: 3831 | Main Street: MALLARD_DR | Cross Street: SAXONBURY_WY | Location: | E |

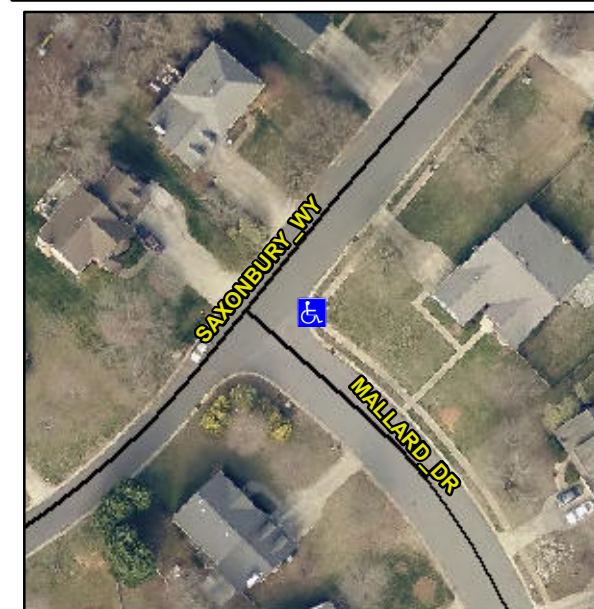
| ADA ID: B0943AA7BE5E | Ramp Type: Perp | Initial Pass/Fail: Fail | Overall Compliance: No | Severity Score: 22.5 |

Not Found, R304.5.1, R304.2.2, R304.5.3

| Compliance | Description | Data | Compliance | Description | Data |
|---|---|---|---|---|---|
| N/A | Ramp Length (in) | 61.0 | No | Ramp Slope (%) | 9.9 |
| No | Ramp Width (in) | 40.5 | No | Ramp XSlope (%) | 4.7 |

Possible Solutions:

Remove & Replace Entire Ramp.
