Access Compliance Report Public Rights-of-Way (Curb Ramps)

Intersection ID: 32102 Main Street: BLUE_HERON_DR Cross Street: CASTLE_PINE_CT Location: NW Ramp Type: Directional1 **Overall Compliance: No** ADA ID: B0988E213948 Initial Pass/Fail: Fail **Severity Score:** 1.25

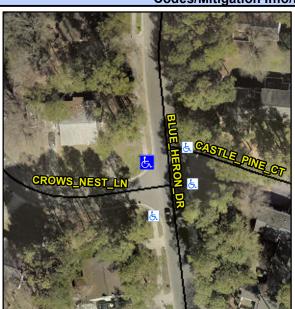
Field Measurements/Component Compliance							
Compl	liance Description	Data	Comp	liance Description	Data		
N/A	Ramp Length (in)	115.0	N/A	Grade Break?	N/A		
Yes	Ramp Width (in)	57.0	N/A	Grade Break Slope (%)	0.0		
Yes	Ramp Slope (%)	7.1	N/A	Grade Break XSlope (%)	0.0		
No	Ramp XSlope (%)	3.0					
N/A	Flare Type LT	N/A	N/A	Flare Type RT	N/A		
N/A	Flare Slope LT (%)	N/A	N/A	Flare Slope RT (%)	0.0		
N/A	Flare Traversable LT?	N/A	N/A	Flare Traversable RT?	N/A		
N/A	Landing Length (in)	0.0	N/A	DWS Provided?	N/A		
N/A	Landing Width (in)	0.0	N/A	DWS Contrast?	N/A		
N/A	Landing Slope (%)	0.0	N/A	DWS Length (in)	N/A		
N/A	Landing X Slope (%)	0.0	N/A	DWS Full Width?	N/A		
N/A	Landing Curb? (Y/N)	N/A	N/A	DWS Offset LT (in)	N/A		
N/A	Shared Landing?	N/A	N/A	DWS Offset RT (in)	N/A		
N/A	Gutter Ponding?	0.0	N/A	Gutter Slope (%)	N/A		
N/A	Gutter Lip Ht (in)	0.0	N/A	Gutter X Slope (%)	N/A		
N/A	Painted X Walk1?	No		Road Slope (%)	2.0

i ossibic ociation	
Possible Solutions:	Co
Remove & Replace Entire Ramp.	N/A
•	Yes
	Yes
	No
	N/A
	N/A
Surveyor Notes:	N/A
N/A	N/A
	N/A
	N/A
	N/A
PROW/ADA:	N/A
R304.5.3	N/A
	N/A
	N/A
	N/A

Total Cost:	\$ 1600.00
