Access Compliance Report

Public Rights-of-Way

(Curb Ramps)

Intersection ID: 10020415	Main Street: BALLANTYNE_MEDICAL_PL	Cross Street: N/A	Location: SE
ADA ID: B09FE5336EA4	Ramp Type: Perp	Initial Pass/Fail: Fail	Overall Compliance: No
Codes/Mitigation Info/Possible Solution		Field Measurements/Component Compliance	
Severity Score: 1.25

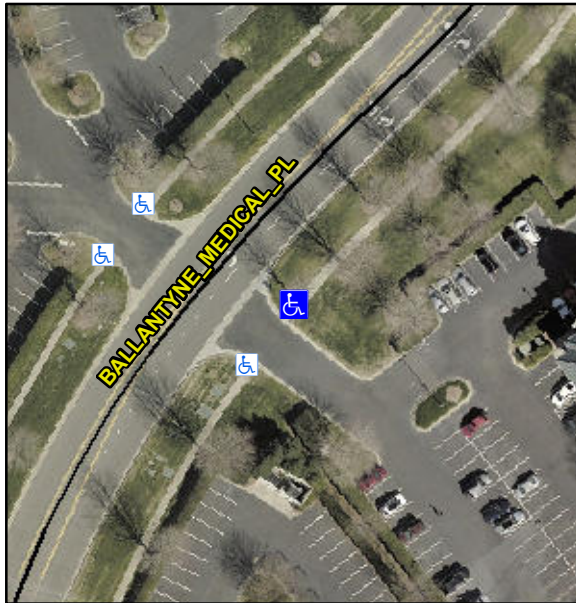
Compliance	Description	Data	Compliance	Description	Data
N/A	Ramp Length (in)	72.0	Yes	Ramp Slope (%)	5.1
Yes	Ramp Width (in)	58.0	No	Ramp XSlope (%)	2.2
N/A	Flare Type LT	N/A	N/A	Flare Type RT	N/A
N/A	Flare Slope LT (%)	N/A	N/A	Flare Slope RT (%)	N/A
N/A	Flare Traversable LT?	N/A	N/A	Flare Traversable RT?	N/A
N/A	Landing Length (in)	N/A	N/A	DWS Provided?	N/A
N/A	Landing Width (in)	N/A	N/A	DWS Contrast?	N/A
N/A	Landing Slope (%)	N/A	N/A	DWS Length (in)	N/A
N/A	Landing X Slope (%)	N/A	N/A	DWS Full Width?	N/A
N/A	Landing Curb? (Y/N)	N/A	N/A	DWS Offset (in)	N/A
N/A	Shared Landing?	N/A			
N/A	Gutter Ponding?	N/A	N/A	Gutter Slope (%)	N/A
N/A	Gutter Lip Ht (in)	N/A	N/A	Gutter X Slope (%)	N/A
N/A	Painted X Walk1?	No	N/A	Painted X Walk2?	N/A
	X Walk 1 Direction	To SW		X Walk 2 Direction	N/A
N/A	X Walk 1 Width (in)	N/A	N/A	X Walk 2 Width (in)	N/A
	X Walk 1 Slope (%)	0.5		X Walk 2 Slope (%)	N/A
	X Walk 1 X Slope (%)	2.6		X Walk 2 X Slope (%)	N/A

N/A	Ramp inside XWalk1?	N/A	N/A	Ramp inside XWalk2?	N/A
	Road Slope (%)	N/A	N/A	Clear Space?	N/A
	Road X Slope (%)	N/A	N/A	Clear Space to XWalk (in)	N/A
N/A	Any Obstructions?	N/A	N/A	Storm Grate/Utility Hazard?	N/A
	Obstruction Type			Storm Grate/Utility Type	
		N/A			N/A
		Yes		Surface Condition? (G/P)	Good

Possible Solutions:

Remove & Replace Entire Ramp.

R304.5.3

\$ 1850.00
