# Access Compliance Report Public Rights-of-Way (Curb Ramps)

Intersection ID: 32311	Main Street: LAUREL_WALK_CT	Cross Street: NEW_PROVIDENCE_LN	Location: NW
ADA ID: B0A2932AA10C	Ramp Type: Perp	Initial Pass/Fail: Fail	Overall Compliance: No Severity Score: 13.75

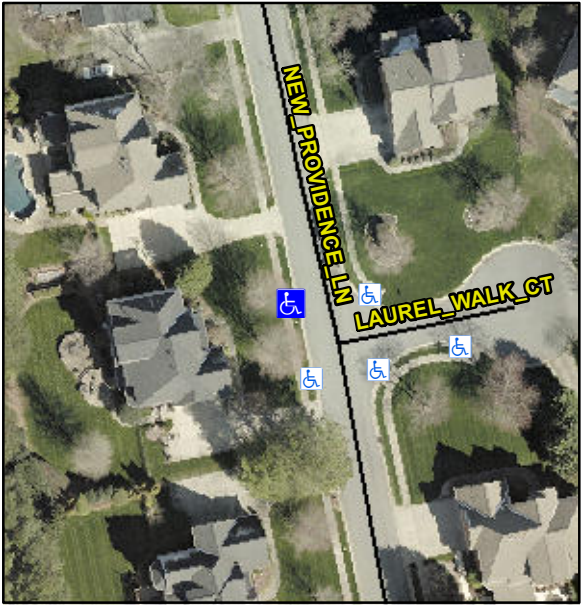
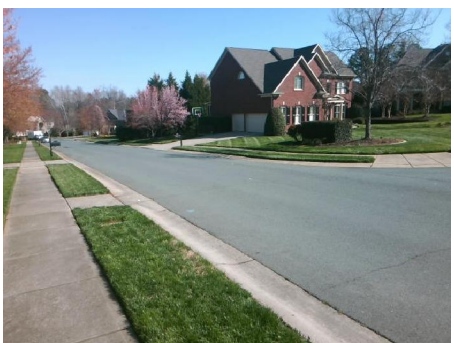
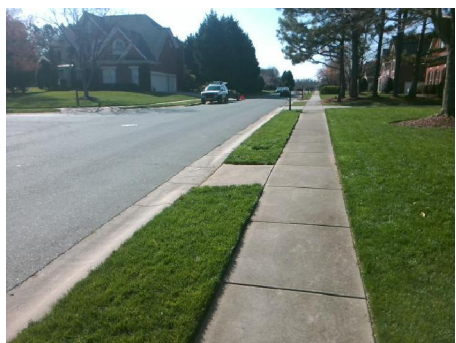
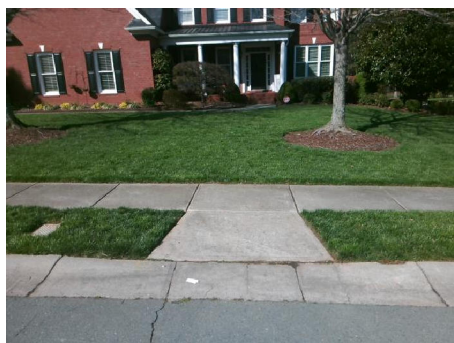
PROW/ADA:  
**R304.2.2, R304.5.3**

Compliance	Description	Data	Compliance	Description	Data
N/A	Ramp Length (in)	46.0	No	Ramp Slope (%)	9.2
Yes	Ramp Width (in)	48.0	No	Ramp XSlope (%)	4.2
N/A	Flare Type LT	N/A	N/A	Flare Type RT	N/A
N/A	Flare Slope LT (%)	N/A	N/A	Flare Slope RT (%)	N/A
N/A	Flare Traversable LT?	N/A	N/A	Flare Traversable RT?	N/A
N/A	Landing Length (in)	N/A	N/A	DWS Provided?	N/A
N/A	Landing Width (in)	N/A	N/A	DWS Contrast?	N/A
N/A	Landing Slope (%)	N/A	N/A	DWS Length (in)	N/A
N/A	Landing X Slope (%)	N/A	N/A	DWS Full Width?	N/A
N/A	Landing Curb? (Y/N)	N/A	N/A	DWS Offset (in)	N/A
N/A	Shared Landing?	N/A			
N/A	Gutter Ponding?	N/A	N/A	Gutter Slope (%)	N/A
N/A	Gutter Lip Ht (in)	N/A	N/A	Gutter X Slope (%)	N/A
N/A	Painted X Walk1?	No	N/A	Painted X Walk2?	N/A
	X Walk 1 Direction	To E		X Walk 2 Direction	N/A
N/A	X Walk 1 Width (in)	N/A	N/A	X Walk 2 Width (in)	N/A
	X Walk 1 Slope (%)	3.9		X Walk 2 Slope (%)	N/A
	X Walk 1 X Slope (%)	1.7		X Walk 2 X Slope (%)	N/A

N/A	Ramp inside XWalk1?	N/A	N/A	Ramp inside XWalk2?	N/A
	Road Slope (%)	N/A	N/A	Clear Space?	N/A
	Road X Slope (%)	N/A	N/A	Clear Space to XWalk (in)	N/A
N/A	Any Obstructions?	N/A	N/A	Storm Grate/Utility Hazard?	N/A
	Obstruction Type			Storm Grate/Utility Type	
			N/A		N/A
			Yes	Surface Condition? (G/P)	Good

Possible Solutions:  
**Remove & Replace Entire Ramp.**
