Access Compliance Report

Public Rights-of-Way

(Curb Ramps)

Intersection ID: 12618	Main Street: E_5TH_ST	Cross Street: N_CALDWELL_ST	Location: S
ADA ID: B0A4D2B5D510	Ramp Type: Perp	Initial Pass/Fail: Fail	Overall Compliance: No
		Severity Score: 12.5

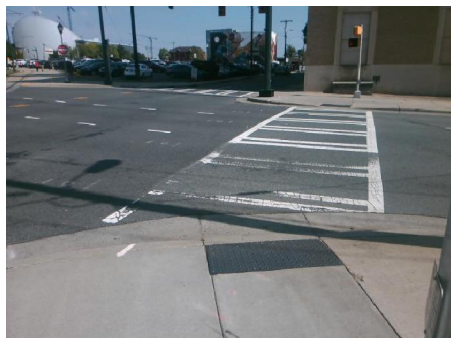
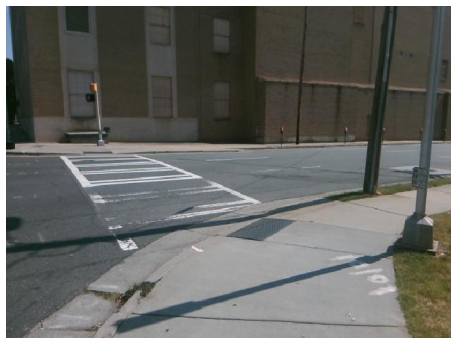
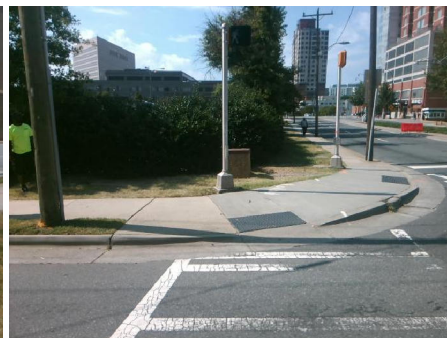
Not Found, R304.2.2

Compliance	Description	Data	Compliance	Description	Data
N/A	Ramp Length (in)	48.0	No	Ramp Slope (%)	8.4
Yes	Ramp Width (in)	49.0	Yes	Ramp XSlope (%)	0.7
N/A	Flare Type LT	N/A	N/A	Flare Type RT	N/A
N/A	Flare Slope LT (%)	N/A	N/A	Flare Slope RT (%)	N/A
N/A	Flare Traversable LT?	N/A	N/A	Flare Traversable RT?	N/A
N/A	Landing Length (in)	N/A	N/A	DWS Provided?	N/A
N/A	Landing Width (in)	N/A	N/A	DWS Contrast?	N/A
N/A	Landing Slope (%)	N/A	N/A	DWS Length (in)	N/A
N/A	Landing X Slope (%)	N/A	N/A	DWS Full Width?	N/A
N/A	Landing Curb? (Y/N)	N/A	N/A	DWS Offset (in)	N/A
N/A	Shared Landing?	N/A			
N/A	Gutter Ponding?	N/A	N/A	Gutter Slope (%)	N/A
N/A	Gutter Lip Ht (in)	N/A	N/A	Gutter X Slope (%)	N/A
N/A	Painted X Walk1?	Yes	N/A	Painted X Walk2?	N/A
	X Walk 1 Direction	To NE		X Walk 2 Direction	N/A
N/A	X Walk 1 Width (in)	110.0	N/A	X Walk 2 Width (in)	N/A
	X Walk 1 Slope (%)	2.6		X Walk 2 Slope (%)	N/A
	X Walk 1 X Slope (%)	3.0		X Walk 2 X Slope (%)	N/A

N/A	Ramp inside XWalk1?	Yes	N/A	Ramp inside XWalk2?	N/A
	Road Slope (%)	N/A	N/A	Clear Space?	N/A
	Road X Slope (%)	N/A	N/A	Clear Space to XWalk (in)	N/A
N/A	Any Obstructions?	N/A	N/A	Storm Grate/Utility Hazard?	N/A
	Obstruction Type			Storm Grate/Utility Type	
		N/A			N/A
			Yes	Surface Condition? (G/P)	Good

Remove & Replace Entire Ramp.
