Access Compliance Report

Public Rights-of-Way

(Curb Ramps)

Intersection ID: 15162	Main Street: EWING_AV	Cross Street: IDEAL_WY	Location: NW
ADA ID: B0BD91314236	Ramp Type: Perp	Initial Pass/Fail: Fail	Overall Compliance: No
		Severity Score: 10

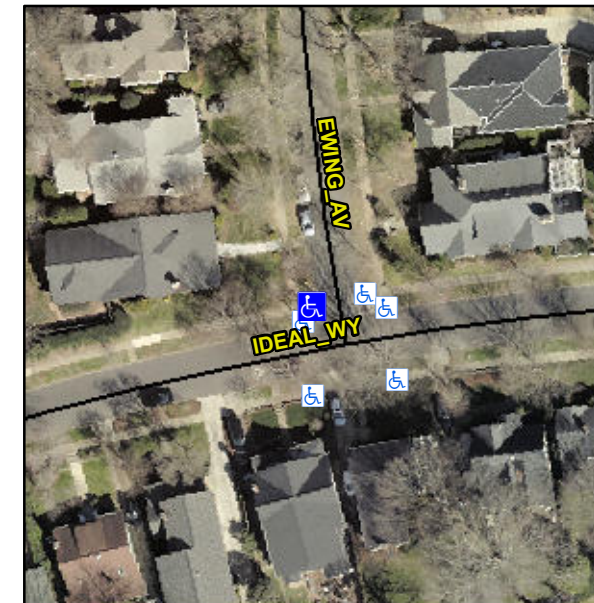
Compliance	Description	Data	Compliance	Description	Data
N/A	Ramp Length (in)	78.0	Yes	Ramp Slope (%)	6.5
No	Ramp Width (in)	36.0	No	Ramp XSlope (%)	4.5
N/A	Flare Type LT	N/A	N/A	Flare Type RT	N/A
N/A	Flare Slope LT (%)	N/A	N/A	Flare Slope RT (%)	N/A
N/A	Flare Traversable LT?	N/A	N/A	Flare Traversable RT?	N/A
N/A	Landing Length (in)	N/A	N/A	DWS Provided?	N/A
N/A	Landing Width (in)	N/A	N/A	DWS Contrast?	N/A
N/A	Landing Slope (%)	N/A	N/A	DWS Length (in)	N/A
N/A	Landing X Slope (%)	N/A	N/A	DWS Full Width?	N/A
N/A	Landing Curb? (Y/N)	N/A	N/A	DWS Offset (in)	N/A
N/A	Shared Landing?	N/A			
N/A	Gutter Ponding?	N/A	N/A	Gutter Slope (%)	N/A
N/A	Gutter Lip Ht (in)	1.0	N/A	Gutter X Slope (%)	N/A
N/A	Painted X Walk1?	No	N/A	Painted X Walk2?	N/A
	X Walk 1 Direction	To E		X Walk 2 Direction	N/A
N/A	X Walk 1 Width (in)	N/A	N/A	X Walk 2 Width (in)	N/A
	X Walk 1 Slope (%)	5.1		X Walk 2 Slope (%)	N/A
	X Walk 1 X Slope (%)	1.0		X Walk 2 X Slope (%)	N/A

N/A	Ramp inside XWalk1?	N/A	N/A	Ramp inside XWalk2?	N/A
	Road Slope (%)	N/A	N/A	Clear Space?	N/A
	Road X Slope (%)	N/A	N/A	Clear Space to XWalk (in)	N/A
N/A	Any Obstructions?	N/A	N/A	Storm Grate/Utility Hazard?	N/A
	Obstruction Type			Storm Grate/Utility Type	
		N/A			N/A
		Yes		Surface Condition? (G/P)	Good

Remove & Replace Entire Ramp.

R304.5.1, R304.5.3

Total Cost: \$ 1850.00
