Access Compliance Report

Public Rights-of-Way

(Curb Ramps)

Intersection ID: 45786	Main Street: LONG_HILL_DR	Cross Street: SHELLVIEW_LN	Location: W
ADA ID: B0CAB3C35898	Ramp Type: PerpDiag	Initial Pass/Fail: Fail	Overall Compliance: No
Severity Score: 8.75			
Codes/Mitigation Info/Possible Solution		Field Measurements/Component Compliance

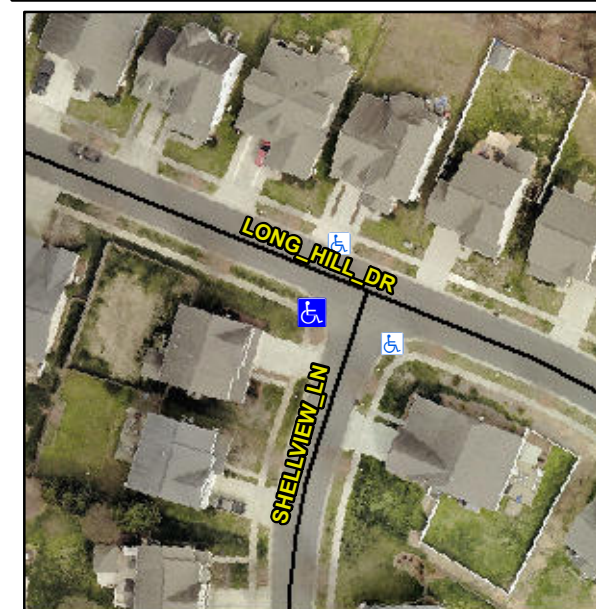
Not Found, R304.5.1

Compliance	Description	Data	Compliance	Description	Data
N/A	Ramp Length (in)	73.0	Yes	Ramp Slope (%)	5.3
No	Ramp Width (in)	47.5	Yes	Ramp XSlope (%)	0.6
N/A	Flare Type LT	N/A	N/A	Flare Type RT	N/A
N/A	Flare Slope LT (%)	N/A	N/A	Flare Slope RT (%)	N/A
N/A	Flare Traversable LT?	N/A	N/A	Flare Traversable RT?	N/A
N/A	Landing Length (in)	N/A	N/A	DWS Provided?	N/A
N/A	Landing Width (in)	N/A	N/A	DWS Contrast?	N/A
N/A	Landing Slope (%)	N/A	N/A	DWS Length (in)	N/A
N/A	Landing X Slope (%)	N/A	N/A	DWS Full Width?	N/A
N/A	Landing Curb? (Y/N)	N/A	N/A	DWS Offset (in)	N/A
N/A	Shared Landing?	N/A			
N/A	Gutter Ponding?	N/A	N/A	Gutter Slope (%)	N/A
N/A	Gutter Lip Ht (in)	N/A	N/A	Gutter X Slope (%)	N/A
N/A	Painted X Walk1?	No	N/A	Painted X Walk2?	No
	X Walk 1 Direction	To SE		X Walk 2 Direction	To NE
N/A	X Walk 1 Width (in)	N/A	N/A	X Walk 2 Width (in)	N/A
	X Walk 1 Slope (%)	1.9		X Walk 2 Slope (%)	1.9
	X Walk 1 X Slope (%)	0.2		X Walk 2 X Slope (%)	2.2

N/A	Ramp inside XWalk1?	N/A	N/A	Ramp inside XWalk2?	N/A
	Road Slope (%)	1.4	N/A	Clear Space?	N/A
	Road X Slope (%)	0.8	N/A	Clear Space to XWalk (in)	N/A
N/A	Any Obstructions?	N/A	N/A	Storm Grate/Utility Hazard?	N/A
	Obstruction Type			Storm Grate/Utility Type	
		N/A			N/A
			Yes	Surface Condition? (G/P)	Good

Possible Solutions:

Remove & Replace Curb Ramp With Two New Directional Ramps or Equivalent.
