Access Compliance Report Public Rights-of-Way (Curb Ramps)

Intersection ID: N/A	Main Street: TRYON_ST	Cross Street: I-485	Location: E
ADA ID: B0CC526DDBF1	Ramp Type: ParaDiag	Initial Pass/Fail: Fail	Overall Compliance: No Severity Score: 13.75

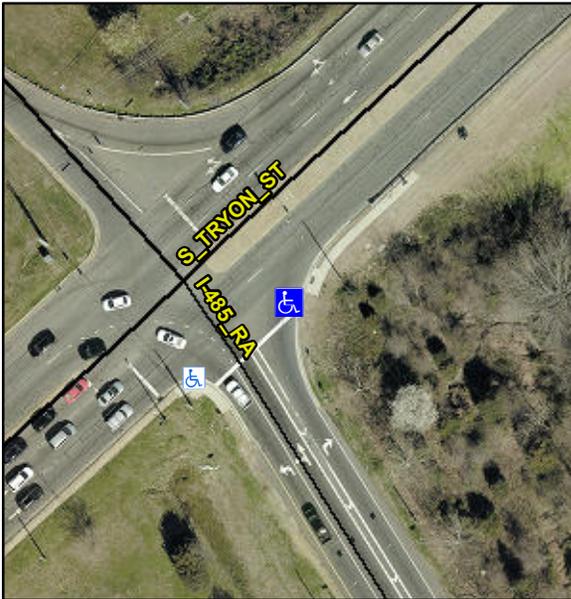
LT RP < 5%

Compliance	Description	Data	Compliance	Description	Data
N/A	Ramp Length LT (in)	58.0	N/A	Ramp Length RT (in)	55.0
Yes	Ramp Width LT (in)	60.0	Yes	Ramp Width RT (in)	60.0
Yes	Ramp Slope LT (%)	4.1	No	Ramp Slope RT (%)	8.4
Yes	Ramp XSlope LT (%)	1.7	No	Ramp XSlope RT (%)	2.5
N/A	Landing Length (in)	N/A	N/A	DWS Provided?	N/A
N/A	Landing Width (in)	N/A	N/A	DWS Contrast?	N/A
N/A	Landing Slope (%)	N/A	N/A	DWS Length (in)	N/A
N/A	Landing X Slope (%)	N/A	N/A	DWS Full Width?	N/A
N/A	Landing Curb? (Y/N)	N/A	N/A	DWS Offset (in)	N/A
N/A	Shared Landing?	N/A			
N/A	Gutter Ponding?	N/A	N/A	Gutter Slope (%)	N/A
N/A	Gutter Lip Ht (in)	N/A	N/A	Gutter X Slope (%)	N/A
N/A	Painted X Walk1?	No	N/A	Painted X Walk2?	No
	X Walk 1 Direction	To NW		X Walk 2 Direction	To SW
N/A	X Walk 1 Width (in)	N/A	N/A	X Walk 2 Width (in)	N/A
	X Walk 1 Slope (%)	2.4		X Walk 2 Slope (%)	2.8
	X Walk 1 X Slope (%)	1.3		X Walk 2 X Slope (%)	2.3
N/A	Ramp inside XWalk1?	N/A	N/A	Ramp inside XWalk2?	N/A

Road Slope (%)	0.9	N/A	Clear Space?	N/A
	Road X Slope (%)	2.8	N/A	Clear Space to XWalk (in)	N/A
N/A	Any Obstructions?	N/A	N/A	Storm Grate/Utility Hazard?	N/A
	Obstruction Type			Storm Grate/Utility Type	
	Total Cost:	\$ 3200.00			
			N/A		N/A
			Yes	Surface Condition? (G/P)	Good
			N/A	Curb Slope (%)	7.2

Remove & Replace Curb Ramp With Two New Directional Ramps or Equivalent.
