# Access Compliance Report

## Public Rights-of-Way

### (Curb Ramps)

Intersection ID: 2464	Main Street: BENTGRASS_RUN_DR	Cross Street: BENTGRASS_RUN_DR	Location: S
ADA ID: B0CEF5B822C8	Ramp Type: PerpDiag	Initial Pass/Fail: Fail	Overall Compliance: No
Severity Score: 21.25			
Codes/Mitigation Info/Possible Solution		Field Measurements/Component Compliance

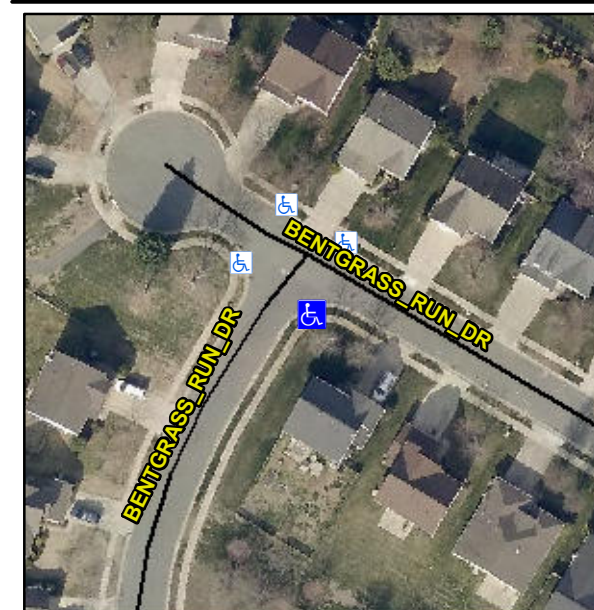
**Not Found, R304.5.1, R304.2.2**

Compliance	Description	Data	Compliance	Description	Data
N/A	Ramp Length (in)	50.0	No	Ramp Slope (%)	8.7
No	Ramp Width (in)	44.0	Yes	Ramp XSlope (%)	1.5
N/A	Flare Type LT	N/A	N/A	Flare Type RT	N/A
N/A	Flare Slope LT (%)	N/A	N/A	Flare Slope RT (%)	N/A
N/A	Flare Traversable LT?	N/A	N/A	Flare Traversable RT?	N/A
N/A	Landing Length (in)	N/A	N/A	DWS Provided?	N/A
N/A	Landing Width (in)	N/A	N/A	DWS Contrast?	N/A
N/A	Landing Slope (%)	N/A	N/A	DWS Length (in)	N/A
N/A	Landing X Slope (%)	N/A	N/A	DWS Full Width?	N/A
N/A	Landing Curb? (Y/N)	N/A	N/A	DWS Offset (in)	N/A
N/A	Shared Landing?	N/A			
N/A	Gutter Ponding?	N/A	N/A	Gutter Slope (%)	N/A
N/A	Gutter Lip Ht (in)	N/A	N/A	Gutter X Slope (%)	N/A
N/A	Painted X Walk1?	No	N/A	Painted X Walk2?	No
	X Walk 1 Direction	To NE		X Walk 2 Direction	To NW
N/A	X Walk 1 Width (in)	N/A	N/A	X Walk 2 Width (in)	N/A
	X Walk 1 Slope (%)	1.8		X Walk 2 Slope (%)	0.3
	X Walk 1 X Slope (%)	1.2		X Walk 2 X Slope (%)	2.1

N/A	Ramp inside XWalk1?	N/A	N/A	Ramp inside XWalk2?	N/A
	Road Slope (%)	2.1	N/A	Clear Space?	N/A
	Road X Slope (%)	1.3	N/A	Clear Space to XWalk (in)	N/A
N/A	Any Obstructions?	N/A	N/A	Storm Grate/Utility Hazard?	N/A
	Obstruction Type			Storm Grate/Utility Type	
		N/A			N/A
			Yes	Surface Condition? (G/P)	Good

**Remove & Replace Curb Ramp With Two New Directional Ramps or Equivalent.**
