Access Compliance Report

Public Rights-of-Way

(Curb Ramps)

| Intersection ID: 4864 | Main Street: HARRINGTON_WOODS_RD | Cross Street: NEW_ENGLAND_ST | Location: | N |

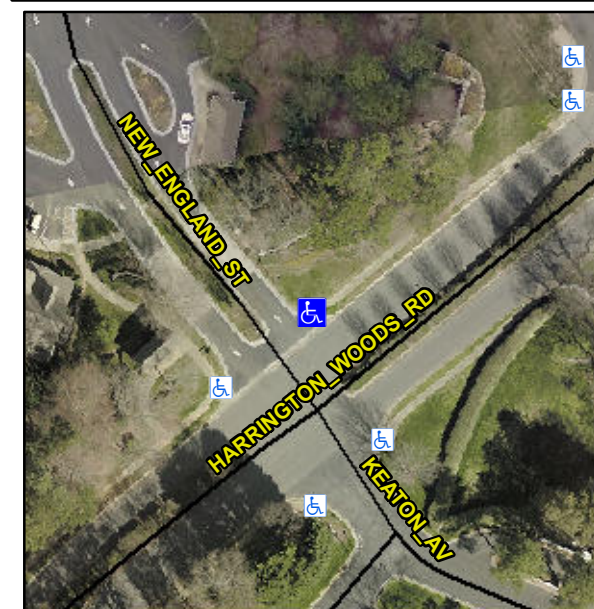
| ADA ID: B0E09CFAE262 | Ramp Type: Perp | Initial Pass/Fail: Fail | Overall Compliance: No | Severity Score: 33.75 |

Not Found, R304.5.1, R304.2.2

| Compliance | Description | Data | Compliance | Description | Data |
|---|---|---|---|---|---|
| N/A | Ramp Length (in) | 48.5 | No | Ramp Slope (%) | 16.5 |
| No | Ramp Width (in) | 43.0 | Yes | Ramp XSlope (%) | 1.2 |

Possible Solutions:

Remove & Replace Entire Ramp.
