# Access Compliance Report

## Public Rights-of-Way

### (Curb Ramps)

| Intersection ID: 42498 | Main Street: ALEXANDER MARTIN_AV | Cross Street: BLAKENEY GREENS_BV | Location: NW |

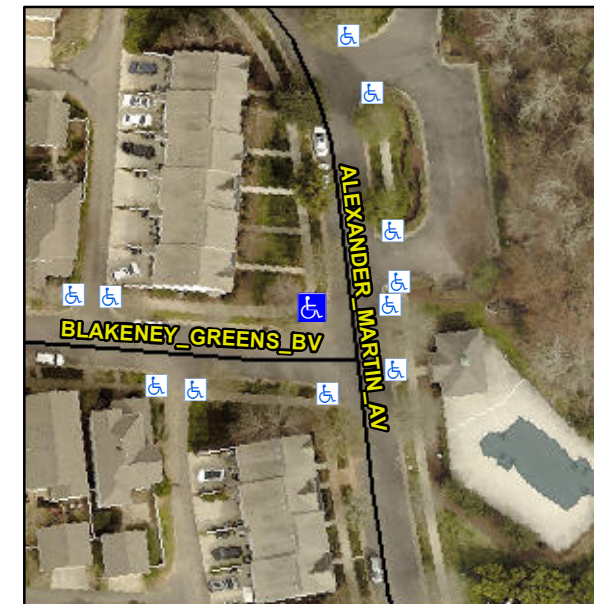
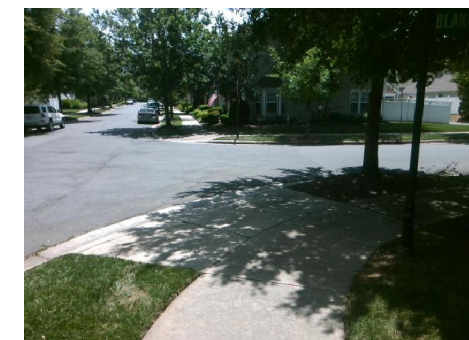
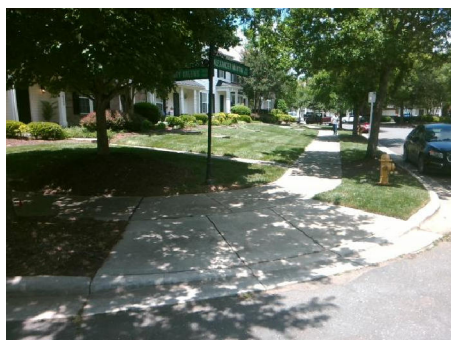
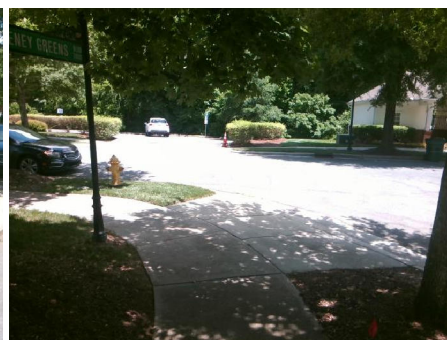
| ADA ID: B0EC10C4180E | Ramp Type: PerpDiag | Initial Pass/Fail: Fail | Overall Compliance: No |
| Codes/Mitigation Info/Possible Solution | | | Severity Score: 35 |

**R304.5.1, R304.2.2, R304.5.3**

| Compliance | Description | Data | Compliance | Description | Data |
|---|---|---|---|---|---|
| N/A | Ramp Length (in) | 69.0 | No | Ramp Slope (%) | 12.5 |
| No | Ramp Width (in) | 47.0 | No | Ramp XSlope (%) | 4.2 |

**Remove & Replace Curb Ramp With Two New Directional Ramps or Equivalent.**

Total Cost: \$ 3200.00
