Access Compliance Report

Public Rights-of-Way

(Curb Ramps)

Intersection ID: 15072	Main Street: DILWORTH_RD_EAST	Cross Street: E WORTHINGTON AV	Location:	N
ADA ID: B0F775A12E6E	Ramp Type: Perp	Initial Pass/Fail: Fail	Overall Compliance: No	Severity Score: 1.25

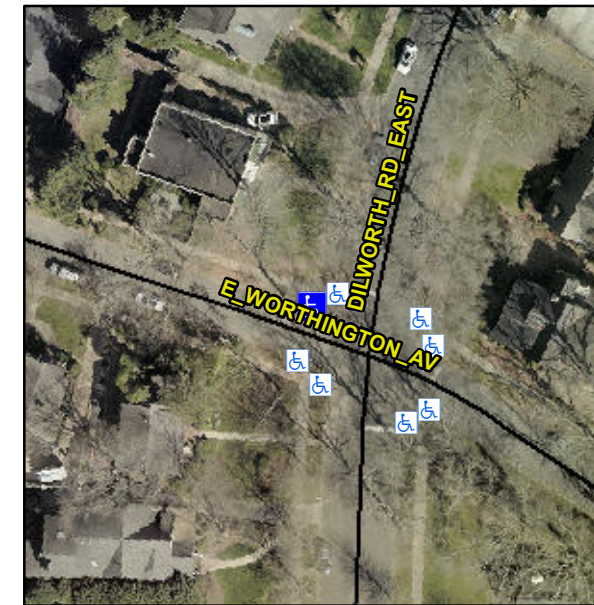
Compliance	Description	Data	Compliance	Description	Data
N/A	Ramp Length (in)	78.0	Yes	Ramp Slope (%)	6.4
Yes	Ramp Width (in)	48.0	No	Ramp XSlope (%)	4.1
N/A	Flare Type LT	N/A	N/A	Flare Type RT	N/A
N/A	Flare Slope LT (%)	N/A	N/A	Flare Slope RT (%)	N/A
N/A	Flare Traversable LT?	N/A	N/A	Flare Traversable RT?	N/A
N/A	Landing Length (in)	N/A	N/A	DWS Provided?	N/A
N/A	Landing Width (in)	N/A	N/A	DWS Contrast?	N/A
N/A	Landing Slope (%)	N/A	N/A	DWS Length (in)	N/A
N/A	Landing X Slope (%)	N/A	N/A	DWS Full Width?	N/A
N/A	Landing Curb? (Y/N)	N/A	N/A	DWS Offset (in)	N/A
N/A	Shared Landing?	N/A			
N/A	Gutter Ponding?	N/A	N/A	Gutter Slope (%)	N/A
N/A	Gutter Lip Ht (in)	2.0	N/A	Gutter X Slope (%)	N/A
N/A	Painted X Walk1?	No	N/A	Painted X Walk2?	N/A
	X Walk 1 Direction	To SW		X Walk 2 Direction	N/A
N/A	X Walk 1 Width (in)	N/A	N/A	X Walk 2 Width (in)	N/A
	X Walk 1 Slope (%)	4.2		X Walk 2 Slope (%)	N/A
	X Walk 1 X Slope (%)	1.4		X Walk 2 X Slope (%)	N/A

N/A	Ramp inside XWalk1?	N/A	N/A	Ramp inside XWalk2?	N/A
	Road Slope (%)	N/A	N/A	Clear Space?	N/A
	Road X Slope (%)	N/A	N/A	Clear Space to XWalk (in)	N/A
N/A	Any Obstructions?	N/A	N/A	Storm Grate/Utility Hazard?	N/A
	Obstruction Type			Storm Grate/Utility Type	
		N/A			N/A
			Yes	Surface Condition? (G/P)	Good

Possible Solutions:

Remove & Replace Entire Ramp.

R304.5.3

\$ 1850.00
