# Access Compliance Report

## Public Rights-of-Way

### (Curb Ramps)

Intersection ID: 27649	Main Street: BALLANTYNE_COUNTRY_CLUB_DR	Cross Street: ROBINSON_ROCK_CT	Location: SW
ADA ID: B10194F05E52	Ramp Type: Perp	Initial Pass/Fail: Fail	Overall Compliance: No
Severity Score: 10			
Codes/Mitigation Info/Possible Solution		Field Measurements/Component Compliance

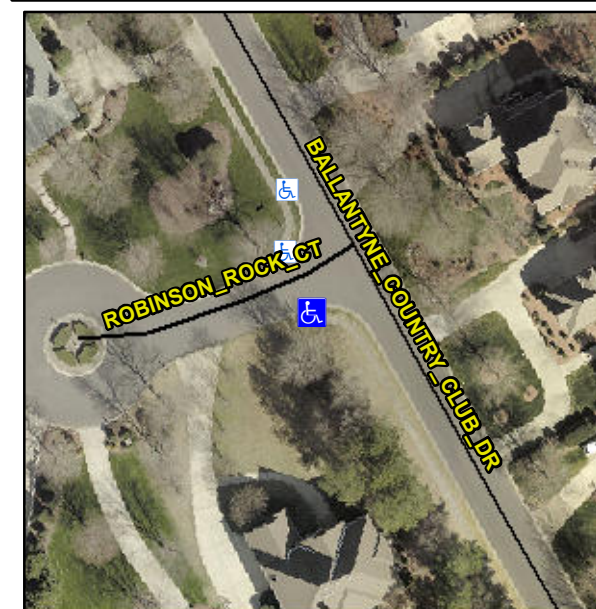
**Not Found, R304.5.1, R304.5.3**

Compliance	Description	Data	Compliance	Description	Data
N/A	Ramp Length (in)	44.0	Yes	Ramp Slope (%)	6.7
No	Ramp Width (in)	39.0	No	Ramp XSlope (%)	3.4
N/A	Flare Type LT	N/A	N/A	Flare Type RT	N/A
N/A	Flare Slope LT (%)	N/A	N/A	Flare Slope RT (%)	N/A
N/A	Flare Traversable LT?	N/A	N/A	Flare Traversable RT?	N/A
N/A	Landing Length (in)	N/A	N/A	DWS Provided?	N/A
N/A	Landing Width (in)	N/A	N/A	DWS Contrast?	N/A
N/A	Landing Slope (%)	N/A	N/A	DWS Length (in)	N/A
N/A	Landing X Slope (%)	N/A	N/A	DWS Full Width?	N/A
N/A	Landing Curb? (Y/N)	N/A	N/A	DWS Offset (in)	N/A
N/A	Shared Landing?	N/A			
N/A	Gutter Ponding?	N/A	N/A	Gutter Slope (%)	N/A
N/A	Gutter Lip Ht (in)	N/A	N/A	Gutter X Slope (%)	N/A
N/A	Painted X Walk1?	No	N/A	Painted X Walk2?	N/A
	X Walk 1 Direction	To N		X Walk 2 Direction	N/A
N/A	X Walk 1 Width (in)	N/A	N/A	X Walk 2 Width (in)	N/A
	X Walk 1 Slope (%)	1.4		X Walk 2 Slope (%)	N/A
	X Walk 1 X Slope (%)	2.3		X Walk 2 X Slope (%)	N/A

N/A	Ramp inside XWalk1?	N/A	N/A	Ramp inside XWalk2?	N/A
	Road Slope (%)	N/A	N/A	Clear Space?	N/A
	Road X Slope (%)	N/A	N/A	Clear Space to XWalk (in)	N/A
N/A	Any Obstructions?	N/A	N/A	Storm Grate/Utility Hazard?	N/A
	Obstruction Type			Storm Grate/Utility Type	
		N/A			N/A
			Yes	Surface Condition? (G/P)	Good

**Remove & Replace Entire Ramp.**
