Access Compliance Report

Public Rights-of-Way

(Curb Ramps)

Intersection ID: 25306	Main Street: CARMEL_RD	Cross Street: QUAIL_RIDGE_DR	Location: E
ADA ID: B105B363D8C5	Ramp Type: PerpDiag	Initial Pass/Fail: Fail	Overall Compliance: No
Severity Score: 21.25			
Codes/Mitigation Info/Possible Solution		Field Measurements/Component Compliance

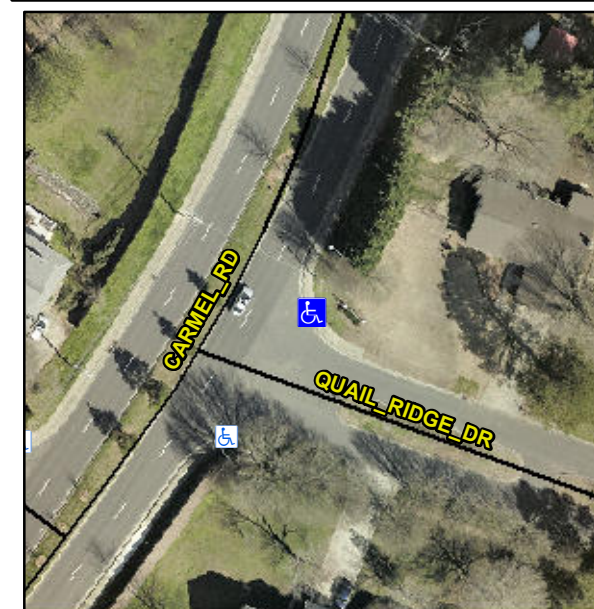
Not Found, R304.5.1, R304.2.2

Compliance	Description	Data	Compliance	Description	Data
N/A	Ramp Length (in)	59.0	No	Ramp Slope (%)	8.7
No	Ramp Width (in)	44.0	Yes	Ramp XSlope (%)	1.0
N/A	Flare Type LT	N/A	N/A	Flare Type RT	N/A
N/A	Flare Slope LT (%)	N/A	N/A	Flare Slope RT (%)	N/A
N/A	Flare Traversable LT?	N/A	N/A	Flare Traversable RT?	N/A
N/A	Landing Length (in)	N/A	N/A	DWS Provided?	N/A
N/A	Landing Width (in)	N/A	N/A	DWS Contrast?	N/A
N/A	Landing Slope (%)	N/A	N/A	DWS Length (in)	N/A
N/A	Landing X Slope (%)	N/A	N/A	DWS Full Width?	N/A
N/A	Landing Curb? (Y/N)	N/A	N/A	DWS Offset (in)	N/A
N/A	Shared Landing?	N/A			
N/A	Gutter Ponding?	N/A	N/A	Gutter Slope (%)	N/A
N/A	Gutter Lip Ht (in)	N/A	N/A	Gutter X Slope (%)	N/A
N/A	Painted X Walk1?	No	N/A	Painted X Walk2?	No
	X Walk 1 Direction	To NW		X Walk 2 Direction	To SW
N/A	X Walk 1 Width (in)	N/A	N/A	X Walk 2 Width (in)	N/A
	X Walk 1 Slope (%)	0.8		X Walk 2 Slope (%)	0.4
	X Walk 1 X Slope (%)	0.1		X Walk 2 X Slope (%)	0.1

N/A	Ramp inside XWalk1?	N/A	N/A	Ramp inside XWalk2?	N/A
	Road Slope (%)	0.5	N/A	Clear Space?	N/A
	Road X Slope (%)	1.5	N/A	Clear Space to XWalk (in)	N/A
N/A	Any Obstructions?	N/A	N/A	Storm Grate/Utility Hazard?	N/A
	Obstruction Type			Storm Grate/Utility Type	
		N/A			N/A
			Yes	Surface Condition? (G/P)	Good

Remove & Replace Curb Ramp With Two New Directional Ramps or Equivalent.
