# Access Compliance Report

## Public Rights-of-Way

### (Curb Ramps)

Intersection ID: 16072	Main Street: MONROE_RD	Cross Street: RICHLAND_DR	Location: NE
ADA ID: B108B647C199	Ramp Type: Perp	Initial Pass/Fail: Fail	Overall Compliance: No
Severity Score: 8.75			
Codes/Mitigation Info/Possible Solution		Field Measurements/Component Compliance

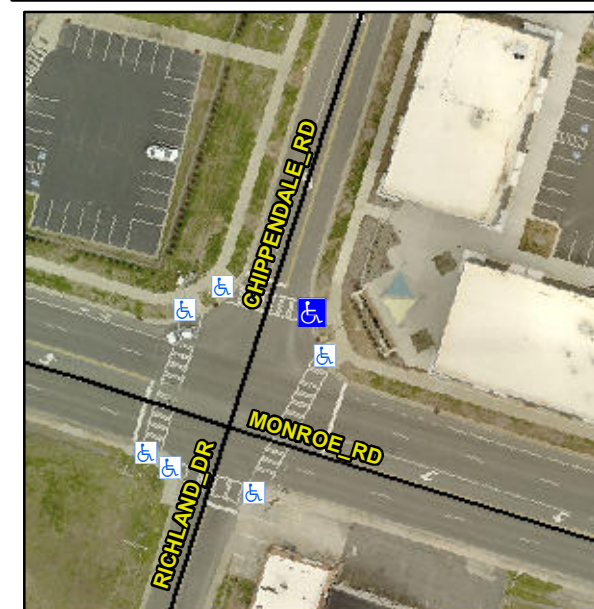
**Not Found, R304.5.1**

Compliance	Description	Data	Compliance	Description	Data
N/A	Ramp Length (in)	97.0	Yes	Ramp Slope (%)	7.0
No	Ramp Width (in)	45.5	Yes	Ramp XSlope (%)	1.8
N/A	Flare Type LT	N/A	N/A	Flare Type RT	N/A
N/A	Flare Slope LT (%)	N/A	N/A	Flare Slope RT (%)	N/A
N/A	Flare Traversable LT?	N/A	N/A	Flare Traversable RT?	N/A
N/A	Landing Length (in)	N/A	N/A	DWS Provided?	N/A
N/A	Landing Width (in)	N/A	N/A	DWS Contrast?	N/A
N/A	Landing Slope (%)	N/A	N/A	DWS Length (in)	N/A
N/A	Landing X Slope (%)	N/A	N/A	DWS Full Width?	N/A
N/A	Landing Curb? (Y/N)	N/A	N/A	DWS Offset (in)	N/A
N/A	Shared Landing?	N/A			
N/A	Gutter Ponding?	N/A	N/A	Gutter Slope (%)	N/A
N/A	Gutter Lip Ht (in)	N/A	N/A	Gutter X Slope (%)	N/A
N/A	Painted X Walk1?	Yes	N/A	Painted X Walk2?	N/A
	X Walk 1 Direction	To NW		X Walk 2 Direction	N/A
N/A	X Walk 1 Width (in)	115.0	N/A	X Walk 2 Width (in)	N/A
	X Walk 1 Slope (%)	0.8		X Walk 2 Slope (%)	N/A
	X Walk 1 X Slope (%)	1.4		X Walk 2 X Slope (%)	N/A

N/A	Ramp inside XWalk1?	Yes	N/A	Ramp inside XWalk2?	N/A
	Road Slope (%)	N/A	N/A	Clear Space?	N/A
	Road X Slope (%)	N/A	N/A	Clear Space to XWalk (in)	N/A
N/A	Any Obstructions?	N/A	N/A	Storm Grate/Utility Hazard?	N/A
	Obstruction Type			Storm Grate/Utility Type	
		N/A			N/A
			Yes	Surface Condition? (G/P)	Good

Possible Solutions:

**Remove & Replace Entire Ramp.**

Total Cost: \$ 1850.00
