# Access Compliance Report

## Public Rights-of-Way (Curb Ramps)

Intersection ID: 10025157	Main Street: DUCKWORTH_AV	Cross Street: N/A	Location: W
ADA ID: B109123557D0	Ramp Type: Directional1	Initial Pass/Fail: Fail	Overall Compliance: No
			Severity Score: 13.75

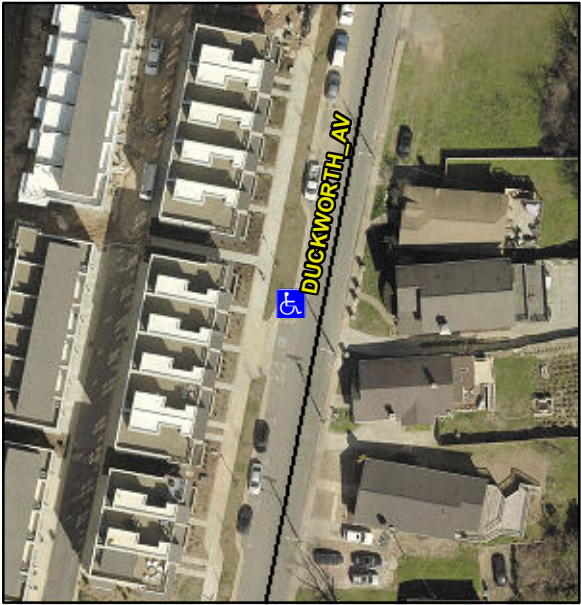
Possible Solutions:		<b>Compliance</b>	<b>Description</b>	<b>Data</b>	
	<b>Remove &amp; Replace Entire Ramp.</b>		N/A	Ramp Length (in)	47.0	
			Yes	Ramp Width (in)	58.0	
			No	Ramp Slope (%)	9.4	
			No	Ramp XSlope (%)	4.7	
			N/A	Flare Type LT	N/A	
			N/A	Flare Slope LT (%)	N/A	
			N/A	Flare Traversable LT?	N/A	
	Surveyor Notes:		N/A	Flare Type RT	N/A	
	<b>ACCESS AISLE RAMP</b>		N/A	Flare Slope RT (%)	N/A	
			N/A	Flare Traversable RT?	N/A	
			N/A	Landing Length (in)	0.0	
			N/A	Landing Width (in)	0.0	
			N/A	Landing Slope (%)	0.0	
			N/A	Landing X Slope (%)	0.0	
	PROW/ADA:		N/A	Landing Curb? (Y/N)	N/A	
	<b>R304.2.2, R304.5.3</b>		N/A	DWS Provided?	N/A	
			N/A	DWS Contrast?	N/A	
			N/A	DWS Length (in)	N/A	
			N/A	DWS Full Width?	N/A	
Street 1 Name	DUCKWORTH AV		N/A	DWS Offset LT (in)	N/A	
Stop Condition-Street 1	None		N/A	DWS Offset RT (in)	N/A

Street 2 Name	N/A		N/A	DWS Slope (%)	N/A	
Stop Condition-Street 2	N/A		N/A	Gutter Slope (%)	N/A	
			N/A	Gutter Lip Ht (in)	0.0	
			N/A	Gutter X Slope (%)	N/A	
			N/A	Painted X Walk1?	No	
			N/A	Road Slope (%)	6.5	
			N/A	X Walk 1 Direction	To E	
			N/A	Road X Slope (%)	2.9	
			N/A	X Walk 1 Width (in)	N/A	
			N/A	Clear Space?	N/A	
			N/A	X Walk 1 Slope (%)	6.5	
			N/A	Clear Space to XWalk (in)	N/A	
			N/A	X Walk 1 X Slope (%)	2.9	
			N/A	Storm Grate/Utility Hazard?	N/A	
			N/A	Storm Grate/Utility Type		
			N/A	Ramp inside XWalk1?	N/A	
			N/A	Any Obstructions?	N/A	
			N/A	Obstruction Type		
			Yes	Surface Condition? (G/P)	Good	
			N/A	Curb Slope (%)	9.9	
Total Cost:		\$ 1600.00
