# Access Compliance Report

## Public Rights-of-Way

### (Curb Ramps)

Intersection ID: 10020348	Main Street: BALLANTYNE COMMONS PY	Cross Street: N/A	Location: SW
ADA ID: B10E71A596C6	Ramp Type: Perp	Initial Pass/Fail: Fail	Overall Compliance: No
Severity Score: 30			
Codes/Mitigation Info/Possible Solution		Field Measurements/Component Compliance

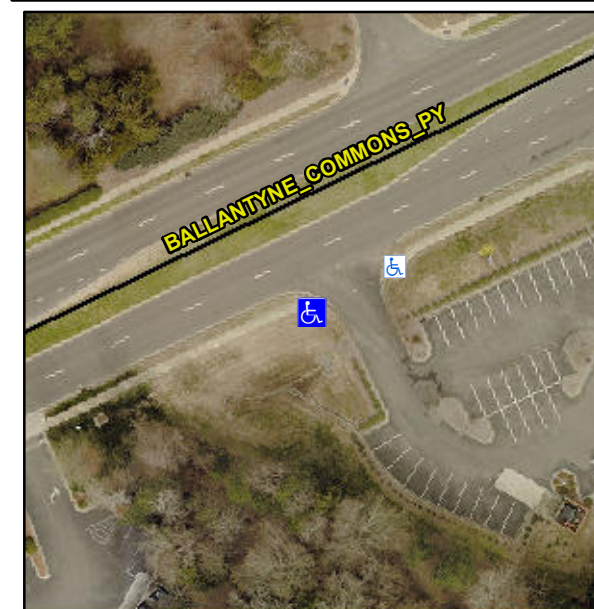
**Not Found, R304.5.1, R304.5.3**

Compliance	Description	Data	Compliance	Description	Data
N/A	Ramp Length (in)	108.0	Yes	Ramp Slope (%)	7.5
No	Ramp Width (in)	34.0	No	Ramp XSlope (%)	6.5
N/A	Flare Type LT	N/A	N/A	Flare Type RT	N/A
N/A	Flare Slope LT (%)	N/A	N/A	Flare Slope RT (%)	N/A
N/A	Flare Traversable LT?	N/A	N/A	Flare Traversable RT?	N/A
N/A	Landing Length (in)	N/A	N/A	DWS Provided?	N/A
N/A	Landing Width (in)	N/A	N/A	DWS Contrast?	N/A
N/A	Landing Slope (%)	N/A	N/A	DWS Length (in)	N/A
N/A	Landing X Slope (%)	N/A	N/A	DWS Full Width?	N/A
N/A	Landing Curb? (Y/N)	N/A	N/A	DWS Offset (in)	N/A
N/A	Shared Landing?	N/A			
N/A	Gutter Ponding?	N/A	N/A	Gutter Slope (%)	N/A
N/A	Gutter Lip Ht (in)	N/A	N/A	Gutter X Slope (%)	N/A
N/A	Painted X Walk1?	No	N/A	Painted X Walk2?	N/A
	X Walk 1 Direction	To E		X Walk 2 Direction	N/A
N/A	X Walk 1 Width (in)	N/A	N/A	X Walk 2 Width (in)	N/A
	X Walk 1 Slope (%)	4.5		X Walk 2 Slope (%)	N/A
	X Walk 1 X Slope (%)	2.0		X Walk 2 X Slope (%)	N/A

N/A	Ramp inside XWalk1?	N/A	N/A	Ramp inside XWalk2?	N/A
	Road Slope (%)	N/A	N/A	Clear Space?	N/A
	Road X Slope (%)	N/A	N/A	Clear Space to XWalk (in)	N/A
N/A	Any Obstructions?	N/A	N/A	Storm Grate/Utility Hazard?	N/A
	Obstruction Type			Storm Grate/Utility Type	
		N/A			N/A
			Yes	Surface Condition? (G/P)	Good

**Remove & Replace Entire Ramp.**
