# Access Compliance Report

## Public Rights-of-Way

### (Curb Ramps)

Intersection ID: 28061	Main Street: CORRYSTONE_DR	Cross Street: WILLOW_ROCK_DR	Location: E
ADA ID: B111CEDE2961	Ramp Type: PerpDiag	Initial Pass/Fail: Fail	Overall Compliance: No
Severity Score: 31.25			
Codes/Mitigation Info/Possible Solution		Field Measurements/Component Compliance

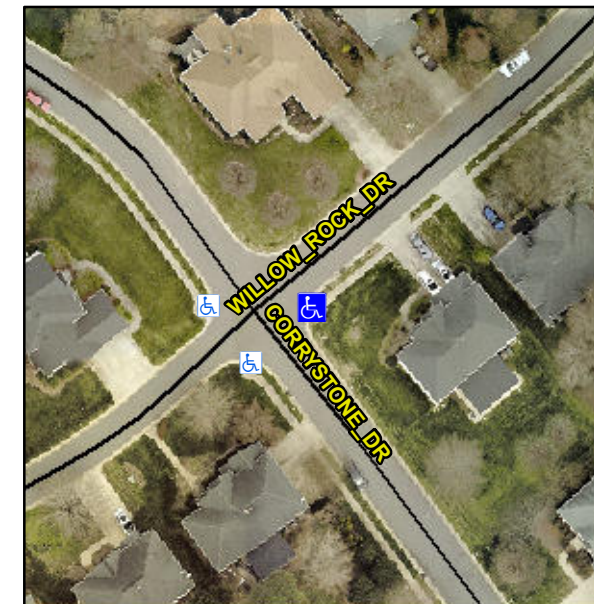
**Not Found, R304.5.1, R304.2.2, R304.5.3**

Compliance	Description	Data	Compliance	Description	Data
N/A	Ramp Length (in)	96.0	No	Ramp Slope (%)	8.8
No	Ramp Width (in)	33.5	No	Ramp XSlope (%)	3.8
N/A	Flare Type LT	N/A	N/A	Flare Type RT	N/A
N/A	Flare Slope LT (%)	N/A	N/A	Flare Slope RT (%)	N/A
N/A	Flare Traversable LT?	N/A	N/A	Flare Traversable RT?	N/A
N/A	Landing Length (in)	N/A	N/A	DWS Provided?	N/A
N/A	Landing Width (in)	N/A	N/A	DWS Contrast?	N/A
N/A	Landing Slope (%)	N/A	N/A	DWS Length (in)	N/A
N/A	Landing X Slope (%)	N/A	N/A	DWS Full Width?	N/A
N/A	Landing Curb? (Y/N)	N/A	N/A	DWS Offset (in)	N/A
N/A	Shared Landing?	N/A			
N/A	Gutter Ponding?	N/A	N/A	Gutter Slope (%)	N/A
N/A	Gutter Lip Ht (in)	N/A	N/A	Gutter X Slope (%)	N/A
N/A	Painted X Walk1?	No	N/A	Painted X Walk2?	No
	X Walk 1 Direction	To NW		X Walk 2 Direction	To SW
N/A	X Walk 1 Width (in)	N/A	N/A	X Walk 2 Width (in)	N/A
	X Walk 1 Slope (%)	4.6		X Walk 2 Slope (%)	6.8
	X Walk 1 X Slope (%)	3.1		X Walk 2 X Slope (%)	1.4

Possible Solutions:

**Remove & Replace Curb Ramp With Two New Directional Ramps or Equivalent.**
