# Access Compliance Report

## Public Rights-of-Way

| Intersection ID: 8296 | Main Street: N_CRIGLER_ST | Cross Street: ROZZELLES_FERRY_RD | Location: SE |
| ADA ID: B114514438AF | Ramp Type: Directional1 | Initial Pass/Fail: Pass | Overall Compliance: No |

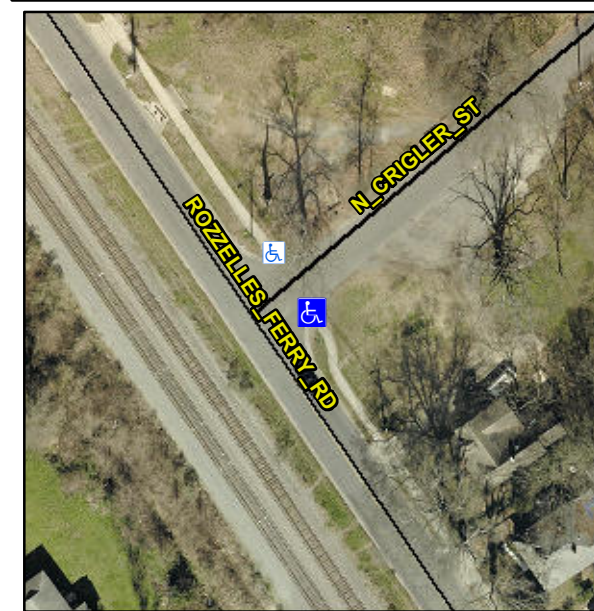
| Severity Score: 5 | | | |

**R305.2, R304.5.4**

| Compliance | Description | Data | Compliance | Description | Data |
|---|---|---|---|---|---|
| N/A | Shared Landing? | No | No | DWS Offset RT (in) | 6.0 |
| Yes | Gutter Ponding? | No | No | Gutter Slope (%) | 7.4 |

**Remove & Replace Detectable Warning System. Remove & Replace Gutter.**

Total Cost: \$ 1550.00
