# Access Compliance Report

## Public Rights-of-Way

### (Curb Ramps)

Intersection ID: 12503	Main Street: ARTY_AV	Cross Street: BERRYHILL_RD	Location: NE
ADA ID: B115DF68556F	Ramp Type: Perp	Initial Pass/Fail: Fail	Overall Compliance: No
		Severity Score: 8.75

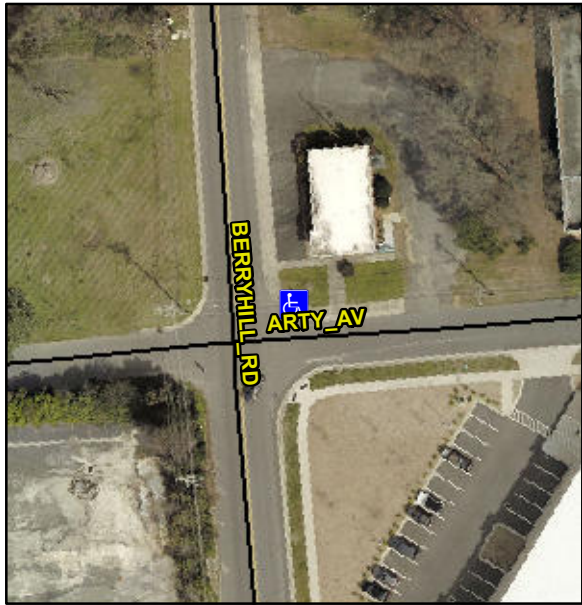
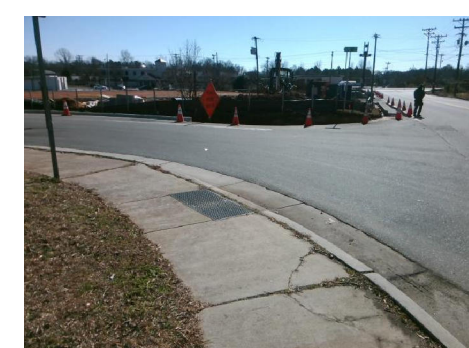
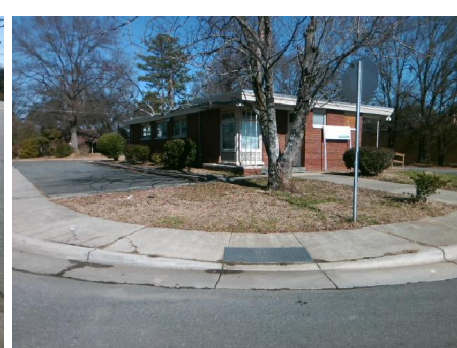
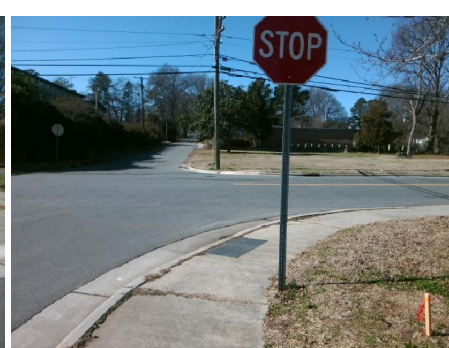
Possible Solutions:		Compliance	Description	Data	Compliance	Description	Data
	Remove & Replace Entire Ramp.		N/A	Ramp Length (in)	60.0	Yes	Ramp Slope (%)	5.7
			No	Ramp Width (in)	41.0	Yes	Ramp XSlope (%)	0.1
			N/A	Flare Type LT	N/A	N/A	Flare Type RT	N/A
			N/A	Flare Slope LT (%)	N/A	N/A	Flare Slope RT (%)	N/A
			N/A	Flare Traversable LT?	N/A	N/A	Flare Traversable RT?	N/A
			N/A	Landing Length (in)	N/A	N/A	DWS Provided?	N/A
			N/A	Landing Width (in)	N/A	N/A	DWS Contrast?	N/A
			N/A	Landing Slope (%)	N/A	N/A	DWS Length (in)	N/A
			N/A	Landing X Slope (%)	N/A	N/A	DWS Full Width?	N/A
Surveyor Notes:	N/A		N/A	Landing Curb? (Y/N)	N/A	N/A	DWS Offset (in)	N/A
			N/A	Shared Landing?	N/A			
	PROW/ADA:		N/A	Gutter Ponding?	N/A	N/A	Gutter Slope (%)	N/A
	Not Found, R304.5.1		N/A	Gutter Lip Ht (in)	N/A	N/A	Gutter X Slope (%)	N/A

N/A	Painted X Walk1?	No	N/A	Painted X Walk2?	N/A
				X Walk 1 Direction	To W		X Walk 2 Direction	N/A
			N/A	X Walk 1 Width (in)	N/A	N/A	X Walk 2 Width (in)	N/A
				X Walk 1 Slope (%)	1.2		X Walk 2 Slope (%)	N/A
				X Walk 1 X Slope (%)	0.1		X Walk 2 X Slope (%)	N/A
			N/A	Ramp inside XWalk1?	N/A	N/A	Ramp inside XWalk2?	N/A
Street 1 Name Stop Condition-Street 2 Street 2 Name Stop Condition-Street 1	BERRYHILL RD StopSign N/A N/A		N/A	Road Slope (%)	N/A	N/A	Clear Space?	N/A
				Road X Slope (%)	N/A	N/A	Clear Space to XWalk (in)	N/A
			N/A	Any Obstructions?	N/A	N/A	Storm Grate/Utility Hazard?	N/A
				Obstruction Type			Storm Grate/Utility Type	
						N/A		N/A
						Yes	Surface Condition? (G/P)	Good
	Total Cost:		\$	1850.00
