Access Compliance Report

Public Rights-of-Way

(Curb Ramps)

Intersection ID: 43653	Main Street: HUNTINGTON_MEADOW_LN	Cross Street: TAGGERT_TRAIL_DR	Location: SE
ADA ID: B11951551420	Ramp Type: Perp	Initial Pass/Fail: Fail	Overall Compliance: No
Severity Score: 21.25			
Codes/Mitigation Info/Possible Solution		Field Measurements/Component Compliance

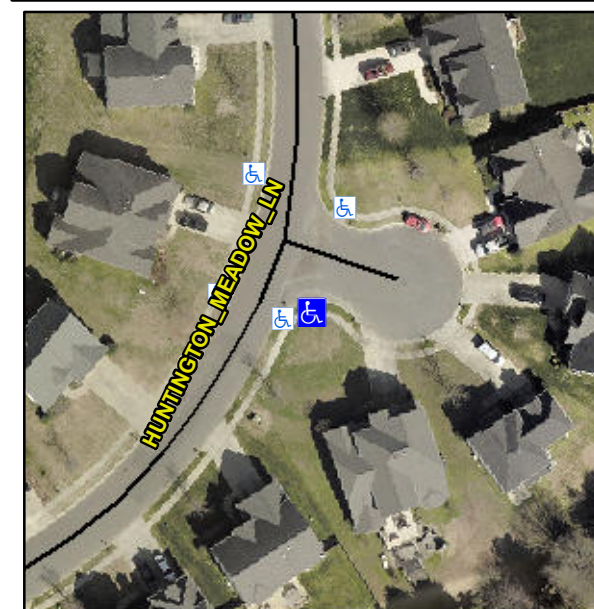
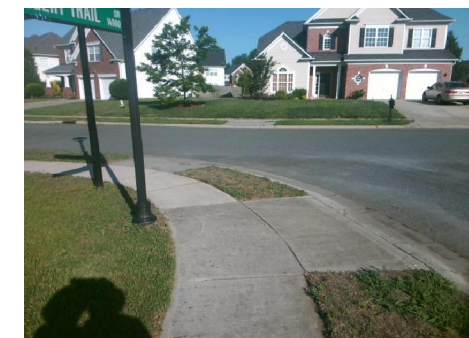
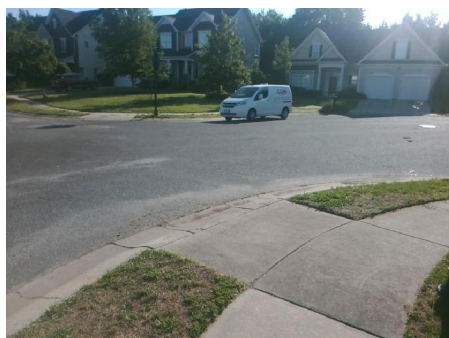
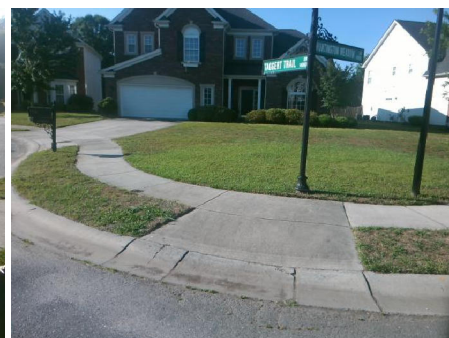
Not Found, R304.5.1, R304.2.2

Compliance	Description	Data	Compliance	Description	Data
N/A	Ramp Length (in)	48.0	No	Ramp Slope (%)	8.8
No	Ramp Width (in)	46.0	Yes	Ramp XSlope (%)	1.0
N/A	Flare Type LT	N/A	N/A	Flare Type RT	N/A
N/A	Flare Slope LT (%)	N/A	N/A	Flare Slope RT (%)	N/A
N/A	Flare Traversable LT?	N/A	N/A	Flare Traversable RT?	N/A
N/A	Landing Length (in)	N/A	N/A	DWS Provided?	N/A
N/A	Landing Width (in)	N/A	N/A	DWS Contrast?	N/A
N/A	Landing Slope (%)	N/A	N/A	DWS Length (in)	N/A
N/A	Landing X Slope (%)	N/A	N/A	DWS Full Width?	N/A
N/A	Landing Curb? (Y/N)	N/A	N/A	DWS Offset (in)	N/A
N/A	Shared Landing?	N/A			
N/A	Gutter Ponding?	N/A	N/A	Gutter Slope (%)	N/A
N/A	Gutter Lip Ht (in)	N/A	N/A	Gutter X Slope (%)	N/A
N/A	Painted X Walk1?	No	N/A	Painted X Walk2?	N/A
	X Walk 1 Direction	To NE		X Walk 2 Direction	N/A
N/A	X Walk 1 Width (in)	N/A	N/A	X Walk 2 Width (in)	N/A
	X Walk 1 Slope (%)	3.7		X Walk 2 Slope (%)	N/A
	X Walk 1 X Slope (%)	0.1		X Walk 2 X Slope (%)	N/A

N/A	Ramp inside XWalk1?	N/A	N/A	Ramp inside XWalk2?	N/A
	Road Slope (%)	N/A	N/A	Clear Space?	N/A
	Road X Slope (%)	N/A	N/A	Clear Space to XWalk (in)	N/A
N/A	Any Obstructions?	N/A	N/A	Storm Grate/Utility Hazard?	N/A
	Obstruction Type			Storm Grate/Utility Type	
		N/A			N/A
			Yes	Surface Condition? (G/P)	Good

Possible Solutions:

Remove & Replace Entire Ramp.
