Access Compliance Report

Public Rights-of-Way

(Curb Ramps)

Intersection ID: 15141	Main Street: IDEAL_WY	Cross Street: MARSHALL_PL	Location:	N
ADA ID: B11BF4DDA8E7	Ramp Type: Directional1	Initial Pass/Fail: Fail	Overall Compliance: No	Severity Score: 25

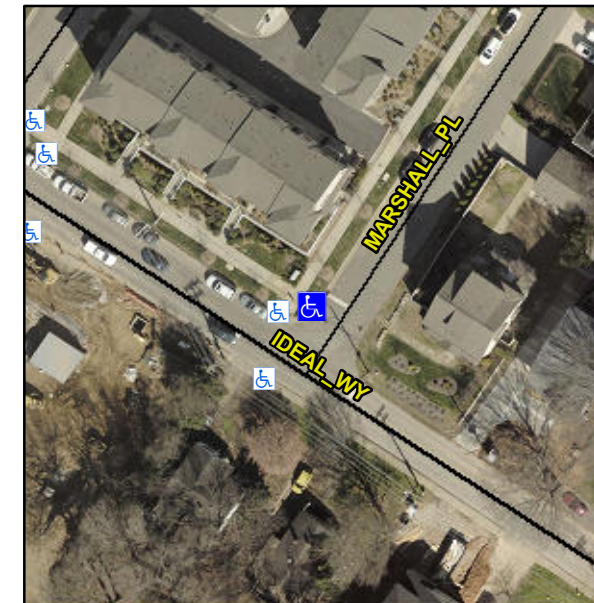
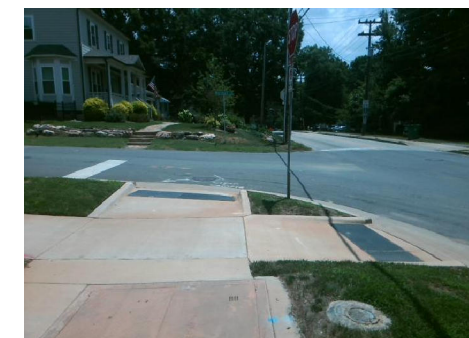
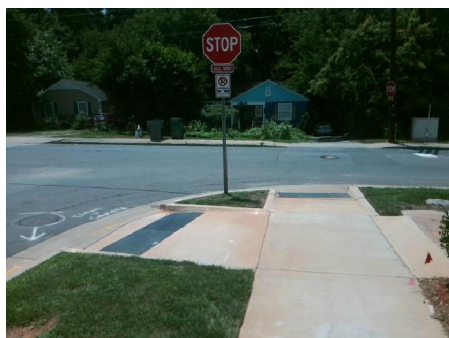
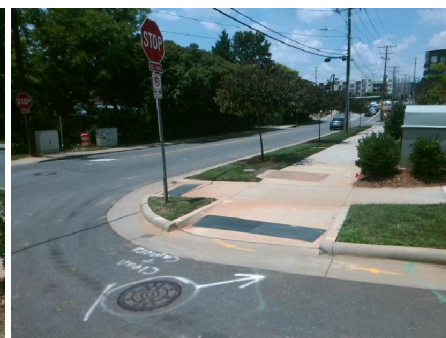
R304.5.3

Compliance	Description	Data	Compliance	Description	Data
N/A	Ramp Length (in)	34.0	N/A	Grade Break?	N/A
Yes	Ramp Width (in)	93.0	N/A	Grade Break Slope (%)	0.0
Yes	Ramp Slope (%)	5.4	N/A	Grade Break XSlope (%)	0.0
No	Ramp XSlope (%)	8.3			
N/A	Flare Type LT	N/A	N/A	Flare Type RT	N/A
N/A	Flare Slope LT (%)	N/A	N/A	Flare Slope RT (%)	0.0
N/A	Flare Traversable LT?	N/A	N/A	Flare Traversable RT?	N/A
N/A	Landing Length (in)	0.0	N/A	DWS Provided?	N/A
N/A	Landing Width (in)	0.0	N/A	DWS Contrast?	N/A
N/A	Landing Slope (%)	0.0	N/A	DWS Length (in)	N/A
N/A	Landing X Slope (%)	0.0	N/A	DWS Full Width?	N/A
N/A	Landing Curb? (Y/N)	N/A	N/A	DWS Offset LT (in)	N/A
N/A	Shared Landing?	N/A	N/A	DWS Offset RT (in)	N/A
N/A	Gutter Ponding?	0.0	N/A	Gutter Slope (%)	N/A
N/A	Gutter Lip Ht (in)	0.0	N/A	Gutter X Slope (%)	N/A
N/A	Painted X Walk1?	No		Road Slope (%)	3.1
	X Walk 1 Direction	To SE		Road X Slope (%)	2.9
	X Walk 1 Width (in)	N/A		Clear Space?	N/A

X Walk 1 Slope (%)	3.1	N/A	Clear Space to XWalk (in)	N/A
	X Walk 1 X Slope (%)	2.9	N/A	Storm Grate/Utility Hazard?	N/A
N/A	Ramp inside XWalk1?	N/A		Storm Grate/Utility Type	
N/A	Any Obstructions?	N/A			N/A
	Obstruction Type		Yes	Surface Condition? (G/P)	Good
			N/A	Curb Slope (%)	7.7

Possible Solutions:

Remove & Replace Entire Ramp.

Total Cost: \$ 1600.00
