# Access Compliance Report

## Public Rights-of-Way

### (Curb Ramps)

Intersection ID: 48459	Main Street: TARPWAY_RD	Cross Street: QUINN_DR	Location: NE
ADA ID: B11CD0D86676	Ramp Type: PerpDiag	Initial Pass/Fail: Fail	Overall Compliance: No
Codes/Mitigation Info/Possible Solution		Field Measurements/Component Compliance	
Severity Score: 33.75

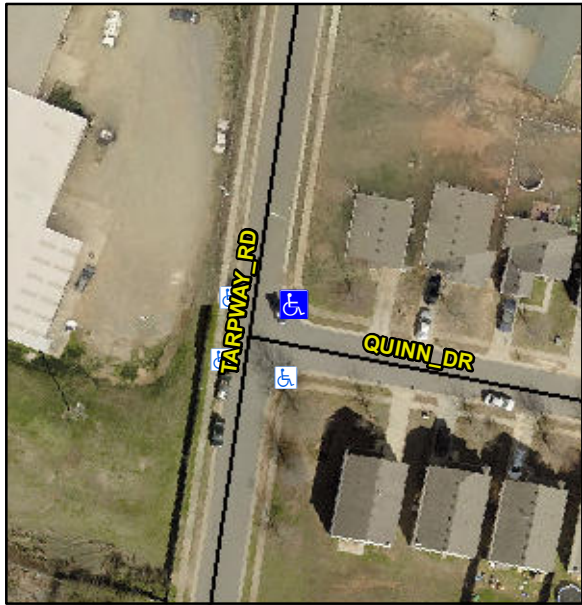
Not Found, R304.5.1, R304.2.2

Compliance	Description	Data	Compliance	Description	Data
N/A	Ramp Length (in)	46.0	No	Ramp Slope (%)	14.6
No	Ramp Width (in)	43.5	Yes	Ramp XSlope (%)	0.0
N/A	Flare Type LT	N/A	N/A	Flare Type RT	N/A
N/A	Flare Slope LT (%)	N/A	N/A	Flare Slope RT (%)	N/A
N/A	Flare Traversable LT?	N/A	N/A	Flare Traversable RT?	N/A
N/A	Landing Length (in)	N/A	N/A	DWS Provided?	N/A
N/A	Landing Width (in)	N/A	N/A	DWS Contrast?	N/A
N/A	Landing Slope (%)	N/A	N/A	DWS Length (in)	N/A
N/A	Landing X Slope (%)	N/A	N/A	DWS Full Width?	N/A
N/A	Landing Curb? (Y/N)	N/A	N/A	DWS Offset (in)	N/A
N/A	Shared Landing?	N/A			
N/A	Gutter Ponding?	N/A	N/A	Gutter Slope (%)	N/A
N/A	Gutter Lip Ht (in)	N/A	N/A	Gutter X Slope (%)	N/A
N/A	Painted X Walk1?	No	N/A	Painted X Walk2?	No
	X Walk 1 Direction	To NW		X Walk 2 Direction	To SW
N/A	X Walk 1 Width (in)	N/A	N/A	X Walk 2 Width (in)	N/A
	X Walk 1 Slope (%)	2.0		X Walk 2 Slope (%)	1.9
	X Walk 1 X Slope (%)	1.8		X Walk 2 X Slope (%)	3.5

N/A	Ramp inside XWalk1?	N/A	N/A	Ramp inside XWalk2?	N/A
	Road Slope (%)	0.3	N/A	Clear Space?	N/A
	Road X Slope (%)	3.5	N/A	Clear Space to XWalk (in)	N/A
N/A	Any Obstructions?	N/A	N/A	Storm Grate/Utility Hazard?	N/A
	Obstruction Type			Storm Grate/Utility Type	
		N/A			N/A
			Yes	Surface Condition? (G/P)	Good

Remove & Replace Curb Ramp With Two New Directional Ramps or Equivalent.
