Access Compliance Report

Public Rights-of-Way

(Curb Ramps)

Intersection ID: N/A	Main Street: PIONEER_AV	Cross Street: CONTINENTAL_BV	Location: NE
ADA ID: B11DA34A9DE7	Ramp Type: Perp	Initial Pass/Fail: Fail	Overall Compliance: No
Severity Score: 12.5			
Codes/Mitigation Info/Possible Solution		Field Measurements/Component Compliance

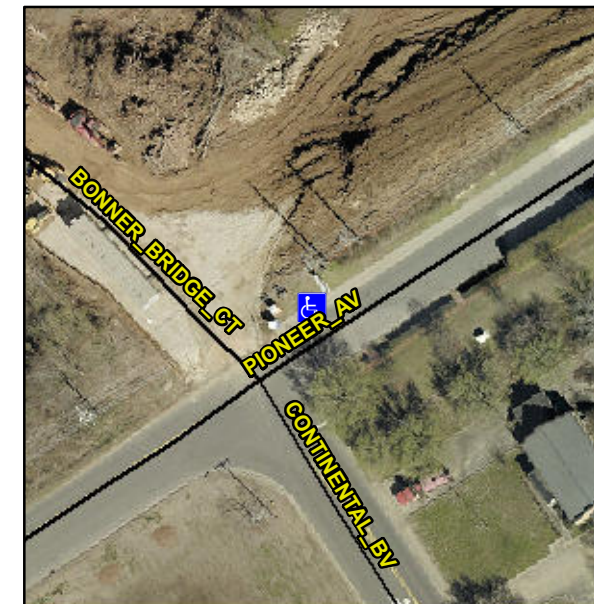
Not Found, R304.2.2

Compliance	Description	Data	Compliance	Description	Data
N/A	Ramp Length (in)	25.0	No	Ramp Slope (%)	9.2
Yes	Ramp Width (in)	48.0	Yes	Ramp XSlope (%)	0.2
N/A	Flare Type LT	N/A	N/A	Flare Type RT	N/A
N/A	Flare Slope LT (%)	N/A	N/A	Flare Slope RT (%)	N/A
N/A	Flare Traversable LT?	N/A	N/A	Flare Traversable RT?	N/A
N/A	Landing Length (in)	N/A	N/A	DWS Provided?	N/A
N/A	Landing Width (in)	N/A	N/A	DWS Contrast?	N/A
N/A	Landing Slope (%)	N/A	N/A	DWS Length (in)	N/A
N/A	Landing X Slope (%)	N/A	N/A	DWS Full Width?	N/A
N/A	Landing Curb? (Y/N)	N/A	N/A	DWS Offset (in)	N/A
N/A	Shared Landing?	N/A			
N/A	Gutter Ponding?	N/A	N/A	Gutter Slope (%)	N/A
N/A	Gutter Lip Ht (in)	N/A	N/A	Gutter X Slope (%)	N/A
N/A	Painted X Walk1?	No	N/A	Painted X Walk2?	N/A
	X Walk 1 Direction	To S		X Walk 2 Direction	N/A
N/A	X Walk 1 Width (in)	N/A	N/A	X Walk 2 Width (in)	N/A
	X Walk 1 Slope (%)	0.6		X Walk 2 Slope (%)	N/A
	X Walk 1 X Slope (%)	0.7		X Walk 2 X Slope (%)	N/A

N/A	Ramp inside XWalk1?	N/A	N/A	Ramp inside XWalk2?	N/A
	Road Slope (%)	N/A	N/A	Clear Space?	N/A
	Road X Slope (%)	N/A	N/A	Clear Space to XWalk (in)	N/A
N/A	Any Obstructions?	N/A	N/A	Storm Grate/Utility Hazard?	N/A
	Obstruction Type			Storm Grate/Utility Type	
		N/A			N/A
			Yes	Surface Condition? (G/P)	Good

Possible Solutions:

Remove & Replace Entire Ramp.

Total Cost: \$ 1850.00
