# Access Compliance Report

## Public Rights-of-Way

### (Curb Ramps)

Intersection ID: 14556	Main Street: E_WORTHINGTON_AV	Cross Street: WINTHROP_AV	Location:	E
ADA ID: B13A810783EB	Ramp Type: Perp	Initial Pass/Fail: Fail	Overall Compliance: No	Severity Score: 1.25

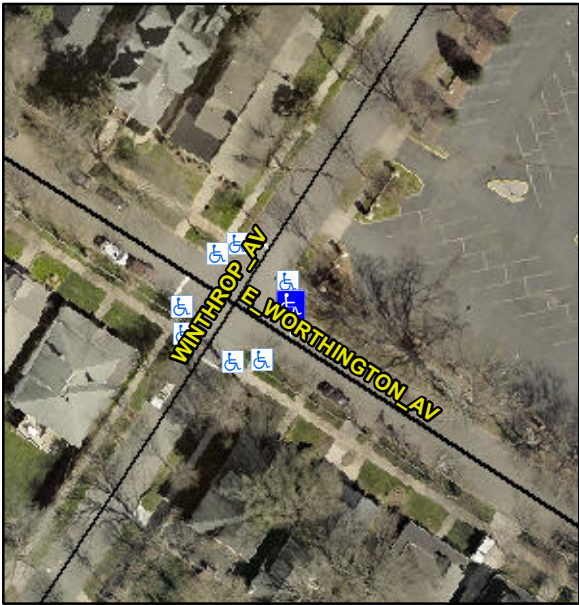
Possible Solutions:		Compliance	Description	Data	Compliance	Description	Data
	Remove & Replace Entire Ramp.		N/A	Ramp Length (in)	83.0	Yes	Ramp Slope (%)	5.3
			Yes	Ramp Width (in)	48.0	No	Ramp XSlope (%)	2.2
			N/A	Flare Type LT	N/A	N/A	Flare Type RT	N/A
			N/A	Flare Slope LT (%)	N/A	N/A	Flare Slope RT (%)	N/A
			N/A	Flare Traversable LT?	N/A	N/A	Flare Traversable RT?	N/A
			N/A	Landing Length (in)	N/A	N/A	DWS Provided?	N/A
			N/A	Landing Width (in)	N/A	N/A	DWS Contrast?	N/A
			N/A	Landing Slope (%)	N/A	N/A	DWS Length (in)	N/A
			N/A	Landing X Slope (%)	N/A	N/A	DWS Full Width?	N/A
Surveyor Notes:	N/A		N/A	Landing Curb? (Y/N)	N/A	N/A	DWS Offset (in)	N/A
			N/A	Shared Landing?	N/A			
			N/A	Gutter Ponding?	N/A	N/A	Gutter Slope (%)	N/A
			N/A	Gutter Lip Ht (in)	1.0	N/A	Gutter X Slope (%)	N/A
			N/A	Painted X Walk1?	No	N/A	Painted X Walk2?	N/A

X Walk 1 Direction	To SW		X Walk 2 Direction	N/A
			N/A	X Walk 1 Width (in)	N/A	N/A	X Walk 2 Width (in)	N/A
				X Walk 1 Slope (%)	2.1		X Walk 2 Slope (%)	N/A
				X Walk 1 X Slope (%)	0.1		X Walk 2 X Slope (%)	N/A
			N/A	Ramp inside XWalk1?	N/A	N/A	Ramp inside XWalk2?	N/A
PROW/ADA:				Road Slope (%)	N/A	N/A	Clear Space?	N/A
				Road X Slope (%)	N/A	N/A	Clear Space to XWalk (in)	N/A
			N/A	Any Obstructions?	N/A	N/A	Storm Grate/Utility Hazard?	N/A
				Obstruction Type			Storm Grate/Utility Type	
					N/A			N/A
						Yes	Surface Condition? (G/P)	Good
Total Cost:		\$ 1850.00
