# Access Compliance Report

## Public Rights-of-Way

### (Curb Ramps)

Intersection ID: 10020377	Main Street: BALLANTYNE CORPORATE PL	Cross Street: N/A	Location: NE
ADA ID: B1595B73AC33	Ramp Type: PerpDiag	Initial Pass/Fail: Fail	Overall Compliance: No
Severity Score: 31.25			
Codes/Mitigation Info/Possible Solution		Field Measurements/Component Compliance

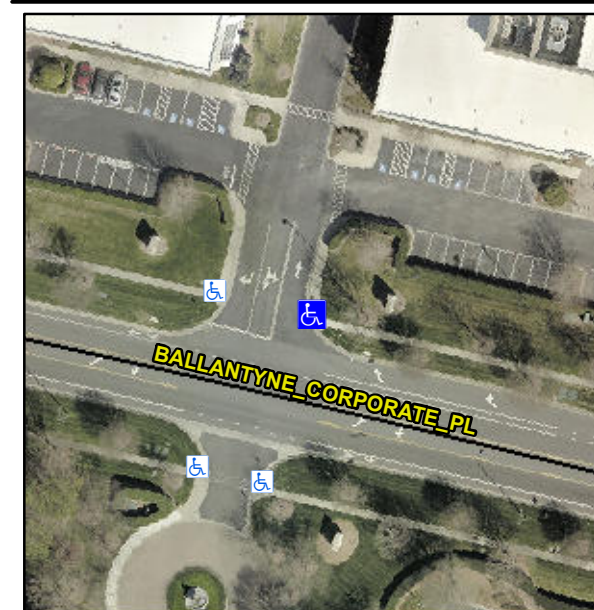
Compliance	Description	Data	Compliance	Description	Data
N/A	Ramp Length (in)	58.0	No	Ramp Slope (%)	8.6
No	Ramp Width (in)	35.0	No	Ramp XSlope (%)	2.6
N/A	Flare Type LT	N/A	N/A	Flare Type RT	N/A
N/A	Flare Slope LT (%)	N/A	N/A	Flare Slope RT (%)	N/A
N/A	Flare Traversable LT?	N/A	N/A	Flare Traversable RT?	N/A
N/A	Landing Length (in)	N/A	N/A	DWS Provided?	N/A
N/A	Landing Width (in)	N/A	N/A	DWS Contrast?	N/A
N/A	Landing Slope (%)	N/A	N/A	DWS Length (in)	N/A
N/A	Landing X Slope (%)	N/A	N/A	DWS Full Width?	N/A
N/A	Landing Curb? (Y/N)	N/A	N/A	DWS Offset (in)	N/A
N/A	Shared Landing?	N/A			
N/A	Gutter Ponding?	N/A	N/A	Gutter Slope (%)	N/A
N/A	Gutter Lip Ht (in)	N/A	N/A	Gutter X Slope (%)	N/A
N/A	Painted X Walk1?	No	N/A	Painted X Walk2?	No
	X Walk 1 Direction	To NW		X Walk 2 Direction	To SW
N/A	X Walk 1 Width (in)	N/A	N/A	X Walk 2 Width (in)	N/A
	X Walk 1 Slope (%)	9.8		X Walk 2 Slope (%)	4.6
	X Walk 1 X Slope (%)	0.7		X Walk 2 X Slope (%)	8.0

N/A	Ramp inside XWalk1?	N/A	N/A	Ramp inside XWalk2?	N/A
	Road Slope (%)	1.4	N/A	Clear Space?	N/A
	Road X Slope (%)	6.5	N/A	Clear Space to XWalk (in)	N/A
N/A	Any Obstructions?	N/A	N/A	Storm Grate/Utility Hazard?	N/A
	Obstruction Type			Storm Grate/Utility Type	
		N/A			N/A
			Yes	Surface Condition? (G/P)	Good

**Remove & Replace Curb Ramp With Two New Directional Ramps or Equivalent.**

**R304.5.1, R304.2.2, R304.5.3**
