Access Compliance Report

Public Rights-of-Way

(Curb Ramps)

Intersection ID: 10021845	Main Street: BRIXHAM_HILL_AV	Cross Street: N/A	Location: S
ADA ID: B1639F89207D	Ramp Type: Perp	Initial Pass/Fail: Fail	Overall Compliance: No
Severity Score: 25			
Codes/Mitigation Info/Possible Solution		Field Measurements/Component Compliance

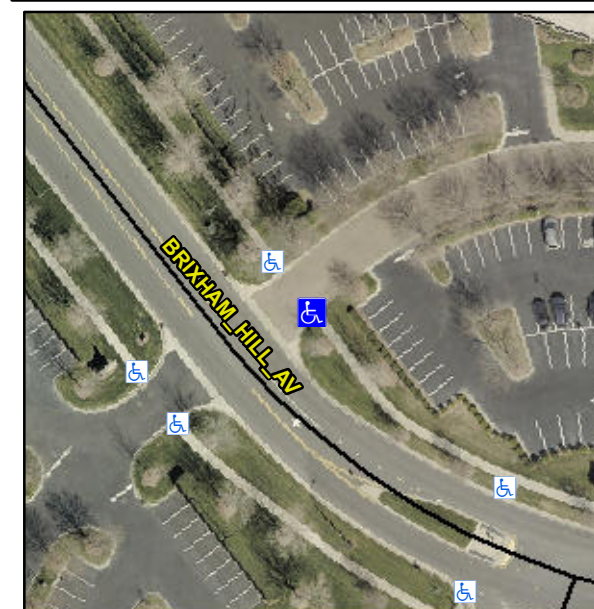
Not Found, R304.2.2

Compliance	Description	Data	Compliance	Description	Data
N/A	Ramp Length (in)	73.0	No	Ramp Slope (%)	13.5
Yes	Ramp Width (in)	59.0	Yes	Ramp XSlope (%)	1.2
N/A	Flare Type LT	N/A	N/A	Flare Type RT	N/A
N/A	Flare Slope LT (%)	N/A	N/A	Flare Slope RT (%)	N/A
N/A	Flare Traversable LT?	N/A	N/A	Flare Traversable RT?	N/A
N/A	Landing Length (in)	N/A	N/A	DWS Provided?	N/A
N/A	Landing Width (in)	N/A	N/A	DWS Contrast?	N/A
N/A	Landing Slope (%)	N/A	N/A	DWS Length (in)	N/A
N/A	Landing X Slope (%)	N/A	N/A	DWS Full Width?	N/A
N/A	Landing Curb? (Y/N)	N/A	N/A	DWS Offset (in)	N/A
N/A	Shared Landing?	N/A			
N/A	Gutter Ponding?	N/A	N/A	Gutter Slope (%)	N/A
N/A	Gutter Lip Ht (in)	N/A	N/A	Gutter X Slope (%)	N/A
N/A	Painted X Walk1?	No	N/A	Painted X Walk2?	N/A
	X Walk 1 Direction	To NW		X Walk 2 Direction	N/A
N/A	X Walk 1 Width (in)	N/A	N/A	X Walk 2 Width (in)	N/A
	X Walk 1 Slope (%)	3.7		X Walk 2 Slope (%)	N/A
	X Walk 1 X Slope (%)	3.3		X Walk 2 X Slope (%)	N/A

Possible Solutions:

Remove & Replace Entire Ramp.
