Access Compliance Report Public Rights-of-Way (Curb Ramps)

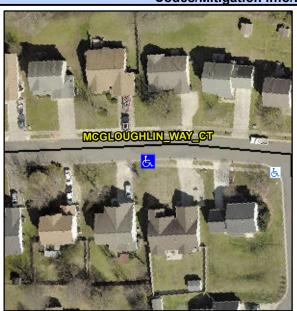
Intersection ID: 10031473 Main Street: MCGLOUGHLIN_WAY_CT Cross Street: N/A Location: S

Cost:	\$ 1850.00

Street 1 Name MCGLOUGHLIN WAY CT
Stop Condition-Street 2 None
Street 2 Name N/A
Stop Condition-Street 1 N/A
