Access Compliance Report

Public Rights-of-Way

(Curb Ramps)

Intersection ID: 15555	Main Street: EASTOVER RIDGE DR	Cross Street: RANDOLPH RD	Location: W
ADA ID: B176FD8D6D8C	Ramp Type: PerpDiag	Initial Pass/Fail: Pass	Overall Compliance: No
Codes/Mitigation Info/Possible Solution		Field Measurements/Component Compliance	
Severity Score: 12.75

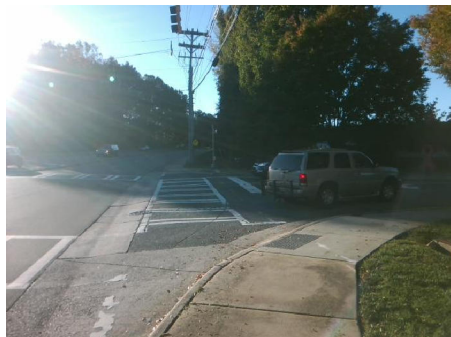
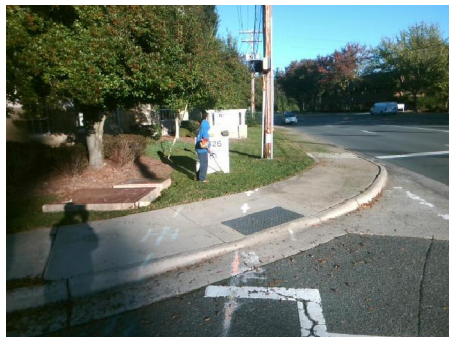
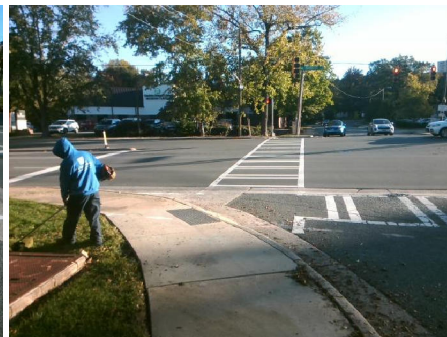
Not Found, R304.5.3, R304.2.1, R304.2.2-Perp, R304.3.2-Para, R305.1.4

Compliance	Description	Data	Compliance	Description	Data
N/A	Ramp Length (in)	70.5	Yes	Ramp Slope (%)	7.2
Yes	Ramp Width (in)	48.0	No	Ramp XSlope (%)	2.8
N/A	Flare Type LT	Sloped	N/A	Flare Type RT	N/A
N/A	Flare Slope LT (%)	1.9	Yes	Flare Slope RT (%)	3.8
N/A	Flare Traversable LT?	Yes	N/A	Flare Traversable RT?	Yes
No	Landing Length (in)	N/A	Yes	DWS Provided?	Yes
No	Landing Width (in)	N/A	Yes	DWS Contrast?	Yes
No	Landing Slope (%)	N/A	Yes	DWS Length (in)	24.0
No	Landing X Slope (%)	N/A	No	DWS Full Width?	No
N/A	Landing Curb? (Y/N)	No	Yes	DWS Offset (in)	2.0
N/A	Shared Landing?	N/A			
Yes	Gutter Ponding?	No	Yes	Gutter Slope (%)	0.1
Yes	Gutter Lip Ht (in)	0.0	Yes	Gutter X Slope (%)	1.5
N/A	Painted X Walk1?	Yes	N/A	Painted X Walk2?	Yes
	X Walk 1 Direction	To SE		X Walk 2 Direction	To NE
N/A	X Walk 1 Width (in)	88.0	N/A	X Walk 2 Width (in)	101.5
	X Walk 1 Slope (%)	3.3		X Walk 2 Slope (%)	4.1
	X Walk 1 X Slope (%)	0.5		X Walk 2 X Slope (%)	4.9

Yes	Ramp inside XWalk1?	Yes	Yes	Ramp inside XWalk2?	Yes
	Road Slope (%)	1.5	N/A	Clear Space?	Yes
	Road X Slope (%)	0.9	Yes	Clear Space to XWalk (in)	111.0
Yes	Any Obstructions?	No	Yes	Storm Grate/Utility Hazard?	No
	Obstruction Type			Storm Grate/Utility Type	
		N/A			N/A
			Yes	Surface Condition? (G/P)	Good

Possible Solutions:

Remove & Replace Curb Ramp With Two New Directional Ramps or Equivalent.
