# Access Compliance Report

## Public Rights-of-Way

### (Curb Ramps)

Intersection ID: 15811	Main Street: BLAIRHILL_RD	Cross Street: S_TRYON_ST	Location: NW
ADA ID: B1802B2D9C7A	Ramp Type: PerpDiag	Initial Pass/Fail: Fail	Overall Compliance: No
			Severity Score: 33.75

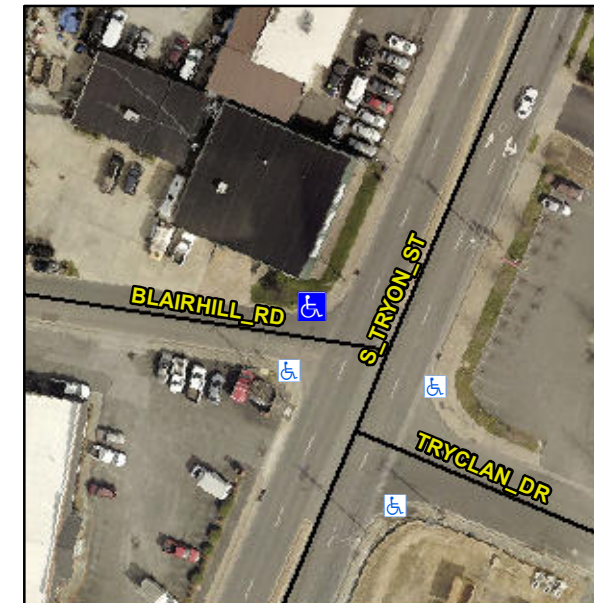
**Not Found, R304.5.1, R304.5.3**

Compliance	Description	Data	Compliance	Description	Data
N/A	Ramp Length (in)	67.0	Yes	Ramp Slope (%)	7.9
No	Ramp Width (in)	41.0	No	Ramp XSlope (%)	8.1
N/A	Flare Type LT	N/A	N/A	Flare Type RT	N/A
N/A	Flare Slope LT (%)	N/A	N/A	Flare Slope RT (%)	N/A
N/A	Flare Traversable LT?	N/A	N/A	Flare Traversable RT?	N/A
N/A	Landing Length (in)	N/A	N/A	DWS Provided?	N/A
N/A	Landing Width (in)	N/A	N/A	DWS Contrast?	N/A
N/A	Landing Slope (%)	N/A	N/A	DWS Length (in)	N/A
N/A	Landing X Slope (%)	N/A	N/A	DWS Full Width?	N/A
N/A	Landing Curb? (Y/N)	N/A	N/A	DWS Offset (in)	N/A
N/A	Shared Landing?	N/A			
N/A	Gutter Ponding?	N/A	N/A	Gutter Slope (%)	N/A
N/A	Gutter Lip Ht (in)	N/A	N/A	Gutter X Slope (%)	N/A
N/A	Painted X Walk1?	No	N/A	Painted X Walk2?	No
	X Walk 1 Direction	To SW		X Walk 2 Direction	To SE
N/A	X Walk 1 Width (in)	N/A	N/A	X Walk 2 Width (in)	N/A
	X Walk 1 Slope (%)	3.0		X Walk 2 Slope (%)	7.0
	X Walk 1 X Slope (%)	4.4		X Walk 2 X Slope (%)	1.4

N/A	Ramp inside XWalk1?	N/A	N/A	Ramp inside XWalk2?	N/A
	Road Slope (%)	4.6	N/A	Clear Space?	N/A
	Road X Slope (%)	3.9	N/A	Clear Space to XWalk (in)	N/A
N/A	Any Obstructions?	N/A	N/A	Storm Grate/Utility Hazard?	N/A
	Obstruction Type			Storm Grate/Utility Type	
		N/A			N/A
			Yes	Surface Condition? (G/P)	Good

**Remove & Replace Curb Ramp With Two New Directional Ramps or Equivalent.**
