## Access Compliance Report Public Rights-of-Way (Curb Ramps)

Intersection ID: 3912 Main Street: DRIWOOD\_CT Cross Street: PROSPERITY\_CHURCH\_RD Location: S

ADA ID: B18FB673E046 Ramp Type: PerpDiag Initial Pass/Fail: Fail Overall Compliance: No Severity Score: 21.25

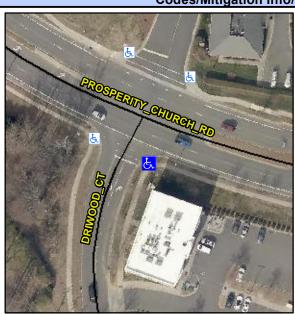
Not Found, R304.5.1, R304.2.2

Compliance Description		Data	Compliance Description		Data
N/A	Ramp Length (in)	65.0	No	Ramp Slope (%)	10.3
No	Ramp Width (in)	44.5	Yes	Ramp XSlope (%)	1.3
N/A	Flare Type LT	N/A	N/A	Flare Type RT	N/A
N/A	Flare Slope LT (%)	N/A	N/A	Flare Slope RT (%)	N/A
N/A	Flare Traversable LT?	N/A	N/A	Flare Traversable RT?	N/A
N/A	Landing Length (in)	N/A	N/A	DWS Provided?	N/A
N/A	Landing Width (in)	N/A	N/A	DWS Contrast?	N/A
N/A	Landing Slope (%)	N/A	N/A	DWS Length (in)	N/A
N/A	Landing X Slope (%)	N/A	N/A	DWS Full Width?	N/A
N/A	Landing Curb? (Y/N)	N/A	N/A	DWS Offset (in)	N/A
N/A	Shared Landing?	N/A			
N/A	Gutter Ponding?	N/A	N/A	Gutter Slope (%)	N/A
N/A	Gutter Lip Ht (in)	N/A	N/A	Gutter X Slope (%)	N/A
N/A	Painted X Walk1?	No	N/A	Painted X Walk2?	No
	X Walk 1 Direction	To NE		X Walk 2 Direction	To NW
N/A	X Walk 1 Width (in)	N/A	N/A	X Walk 2 Width (in)	N/A
	X Walk 1 Slope (%)	1.4		X Walk 2 Slope (%)	1.0
	X Walk 1 X Slope (%)	0.5		X Walk 2 X Slope (%)	1.4

Remove & Replace Curb Ramp With Two New Directional Ramps or Equivalent.
