# Access Compliance Report

## Public Rights-of-Way (Curb Ramps)

| Intersection ID: 19611 | | Main Street: FOXCROFT_RD | | Cross Street: WARBURTON_RD | | Location: NE | | | |
| ADA ID: B1949738EDBF | | Ramp Type: Directional1 | | Initial Pass/Fail: Fail | | Overall Compliance: No | | Severity Score: 10 | |

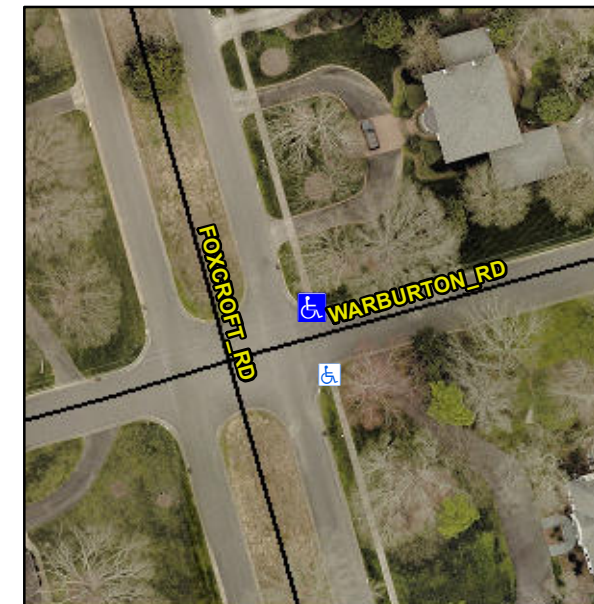
Surveyor Notes:

**ASP LIP 1.0"**

PROW/ADA:

**R304.5.1, R304.5.3**

| Compliance | Description | Data | Compliance | Description | Data |
|---|---|---|---|---|---|
| No | Ramp Width (in) | 46.0 | N/A | Grade Break Slope (%) | 0.0 |
| No | Ramp XSlope (%) | 2.6 | | | |

Possible Solutions:

**Remove & Replace Entire Ramp.**

Total Cost: \$ 1600.00
