# Access Compliance Report

## Public Rights-of-Way

### (Curb Ramps)

| Intersection ID: 24840 | Main Street: REA_RD | Cross Street: MACANDREW_DR | Location: SE |

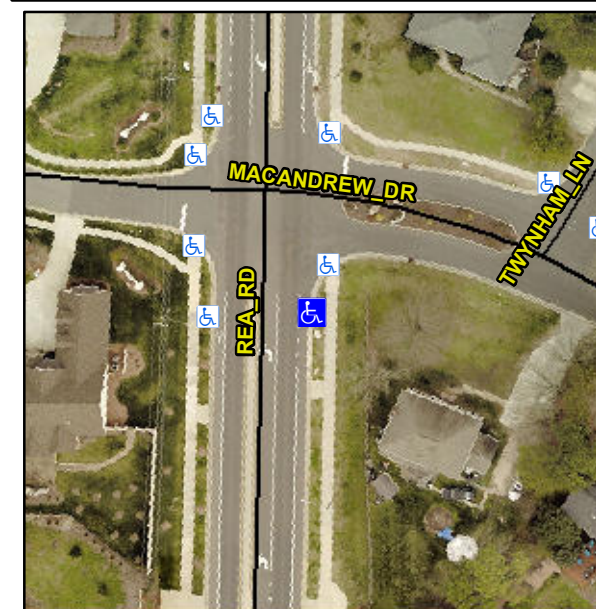
| ADA ID: B198EEF643FF | Ramp Type: Perp | Initial Pass/Fail: Fail | Overall Compliance: No |
| Severity Score: 13.75 | | | |

**Not Found, R304.2.2, R304.5.3**

| Compliance | Description | Data | Compliance | Description | Data |
|---|---|---|---|---|---|
| N/A | Ramp Length (in) | 96.5 | No | Ramp Slope (%) | 8.8 |
| Yes | Ramp Width (in) | 69.0 | No | Ramp XSlope (%) | 2.2 |

**Remove & Replace Entire Ramp.**

Total Cost: \$ 1850.00
