Access Compliance Report

Public Rights-of-Way

(Curb Ramps)

| Intersection ID: 19216 | Main Street: RAMA_RD | Cross Street: SARDIS_RD | Location: SE |

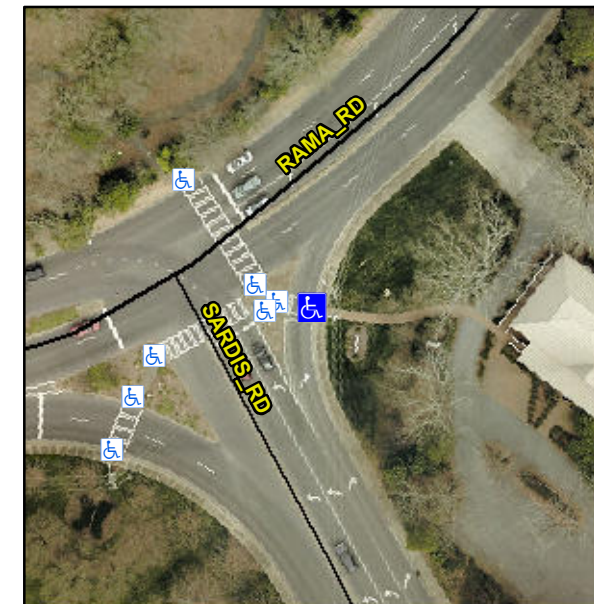
N/A

Not Found, R304.2.2

| Compliance | Description | Data | Compliance | Description | Data |
|---|---|---|---|---|---|
| N/A | Ramp Length (in) | 60.0 | No | Ramp Slope (%) | 9.8 |

Possible Solutions:

Remove & Replace Entire Ramp.
