# Access Compliance Report

## Public Rights-of-Way

### (Curb Ramps)

| Intersection ID: 18383 | Main Street: FURMAN_PL | Cross Street: MURRAYHILL_RD | Location: NW |

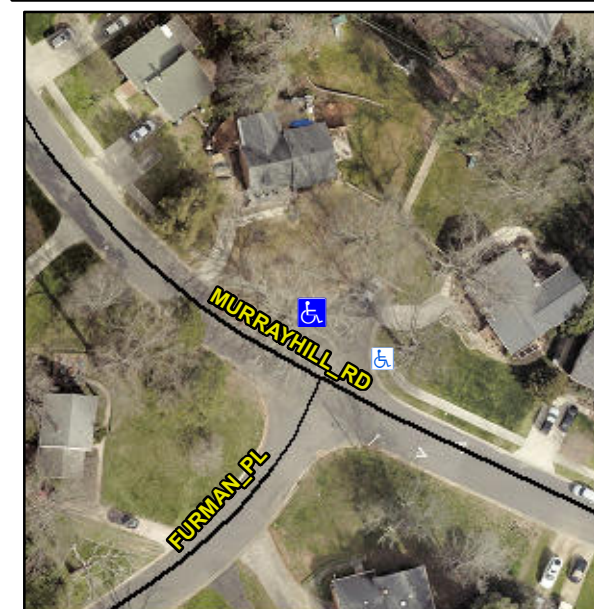
| Severity Score: 37.5 | | | |

**R304.2.2, R304.5.3**

| Compliance | Description | Data | Compliance | Description | Data |
|---|---|---|---|---|---|
| No | Ramp Slope (%) | 15.7 | N/A | Grade Break XSlope (%) | 0.0 |
| No | Ramp XSlope (%) | 5.8 | | | |

**Remove & Replace Entire Ramp.**

Total Cost: \$ 1600.00
