# Access Compliance Report

## Public Rights-of-Way

Intersection ID: 30468	Main Street: GOLDEN_VIEW_DR	Cross Street: OWLS_PERCH_DR	Location: SW
ADA ID: B1B072D8399E	Ramp Type: PerpDiag	Initial Pass/Fail: Fail	Overall Compliance: No
Severity Score: 8.75			
Codes/Mitigation Info/Possible Solution		Field Measurements/Component Compliance

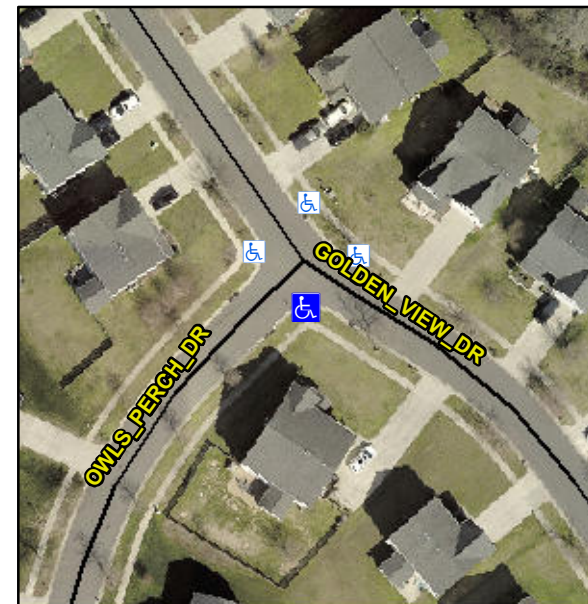
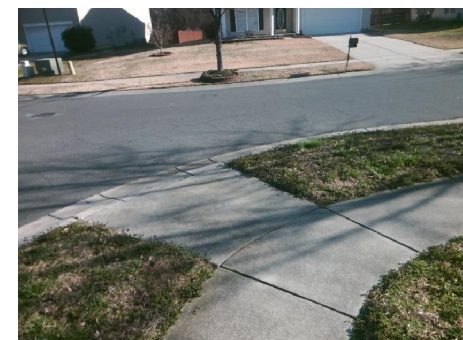
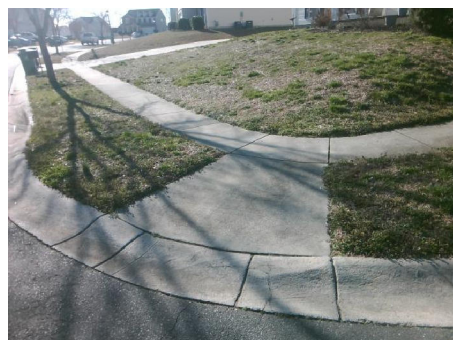
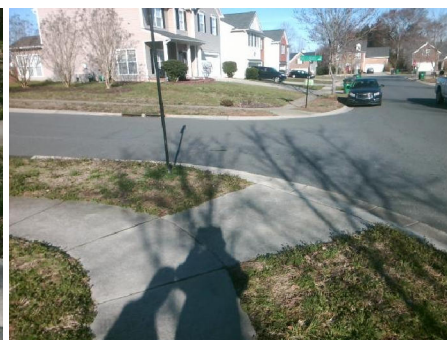
**Not Found, R304.5.1**

Compliance	Description	Data	Compliance	Description	Data
N/A	Ramp Length (in)	84.0	Yes	Ramp Slope (%)	7.0
No	Ramp Width (in)	42.0	Yes	Ramp XSlope (%)	0.0
N/A	Flare Type LT	N/A	N/A	Flare Type RT	N/A
N/A	Flare Slope LT (%)	N/A	N/A	Flare Slope RT (%)	N/A
N/A	Flare Traversable LT?	N/A	N/A	Flare Traversable RT?	N/A
N/A	Landing Length (in)	N/A	N/A	DWS Provided?	N/A
N/A	Landing Width (in)	N/A	N/A	DWS Contrast?	N/A
N/A	Landing Slope (%)	N/A	N/A	DWS Length (in)	N/A
N/A	Landing X Slope (%)	N/A	N/A	DWS Full Width?	N/A
N/A	Landing Curb? (Y/N)	N/A	N/A	DWS Offset (in)	N/A
N/A	Shared Landing?	N/A			
N/A	Gutter Ponding?	N/A	N/A	Gutter Slope (%)	N/A
N/A	Gutter Lip Ht (in)	N/A	N/A	Gutter X Slope (%)	N/A
N/A	Painted X Walk1?	No	N/A	Painted X Walk2?	No
	X Walk 1 Direction	To NE		X Walk 2 Direction	To NW
N/A	X Walk 1 Width (in)	N/A	N/A	X Walk 2 Width (in)	N/A
	X Walk 1 Slope (%)	2.0		X Walk 2 Slope (%)	1.1
	X Walk 1 X Slope (%)	0.9		X Walk 2 X Slope (%)	3.2

N/A	Ramp inside XWalk1?	N/A	N/A	Ramp inside XWalk2?	N/A
	Road Slope (%)	0.6	N/A	Clear Space?	N/A
	Road X Slope (%)	3.0	N/A	Clear Space to XWalk (in)	N/A
N/A	Any Obstructions?	N/A	N/A	Storm Grate/Utility Hazard?	N/A
	Obstruction Type			Storm Grate/Utility Type	
		N/A			N/A
			Yes	Surface Condition? (G/P)	Good

**Remove & Replace Curb Ramp With Two New Directional Ramps or Equivalent.**
