# Access Compliance Report

## Public Rights-of-Way

### (Curb Ramps)

Intersection ID: 2703	Main Street: CROWNVISTA_DR	Cross Street: STARGAZE_LN	Location:	N
ADA ID: B1B43F11CEBB	Ramp Type: PerpDiag	Initial Pass/Fail: Fail	Overall Compliance: No	Severity Score: 10

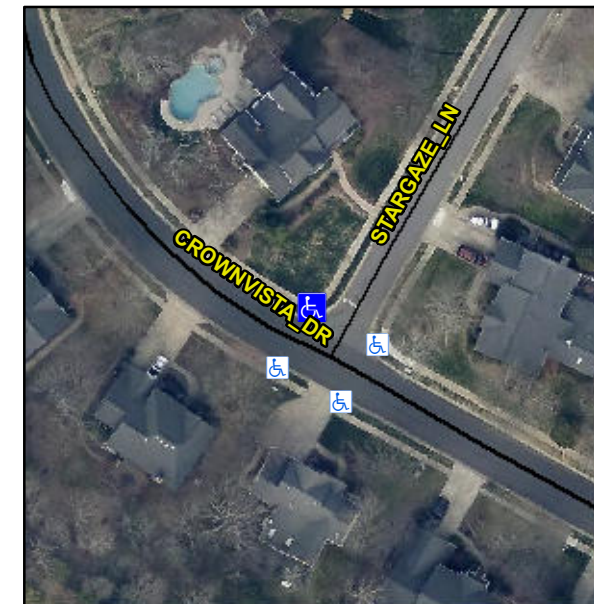
**Not Found, R304.5.1, R304.5.3**

Compliance	Description	Data	Compliance	Description	Data
N/A	Ramp Length (in)	45.0	Yes	Ramp Slope (%)	6.2
No	Ramp Width (in)	42.0	No	Ramp XSlope (%)	3.7
N/A	Flare Type LT	N/A	N/A	Flare Type RT	N/A
N/A	Flare Slope LT (%)	N/A	N/A	Flare Slope RT (%)	N/A
N/A	Flare Traversable LT?	N/A	N/A	Flare Traversable RT?	N/A
N/A	Landing Length (in)	N/A	N/A	DWS Provided?	N/A
N/A	Landing Width (in)	N/A	N/A	DWS Contrast?	N/A
N/A	Landing Slope (%)	N/A	N/A	DWS Length (in)	N/A
N/A	Landing X Slope (%)	N/A	N/A	DWS Full Width?	N/A
N/A	Landing Curb? (Y/N)	N/A	N/A	DWS Offset (in)	N/A
N/A	Shared Landing?	N/A			
N/A	Gutter Ponding?	N/A	N/A	Gutter Slope (%)	N/A
N/A	Gutter Lip Ht (in)	N/A	N/A	Gutter X Slope (%)	N/A
N/A	Painted X Walk1?	No	N/A	Painted X Walk2?	No
	X Walk 1 Direction	To SW		X Walk 2 Direction	To SE
N/A	X Walk 1 Width (in)	N/A	N/A	X Walk 2 Width (in)	N/A
	X Walk 1 Slope (%)	3.1		X Walk 2 Slope (%)	0.5
	X Walk 1 X Slope (%)	2.4		X Walk 2 X Slope (%)	2.5

N/A	Ramp inside XWalk1?	N/A	N/A	Ramp inside XWalk2?	N/A
	Road Slope (%)	3.4	N/A	Clear Space?	N/A
	Road X Slope (%)	1.5	N/A	Clear Space to XWalk (in)	N/A
N/A	Any Obstructions?	N/A	N/A	Storm Grate/Utility Hazard?	N/A
	Obstruction Type			Storm Grate/Utility Type	
		N/A			N/A
			Yes	Surface Condition? (G/P)	Good

**Remove & Replace Curb Ramp With Two New Directional Ramps or Equivalent.**
