Access Compliance Report

Public Rights-of-Way

(Curb Ramps)

Intersection ID: 9189	Main Street: DRUID_CR	Cross Street: STATESVILLE_AV	Location: SE
ADA ID: B1C83661DEAF	Ramp Type: Directional1	Initial Pass/Fail: Fail	Overall Compliance: No
Severity Score: 1.25			
Codes/Mitigation Info/Possible Solution		Field Measurements/Component Compliance

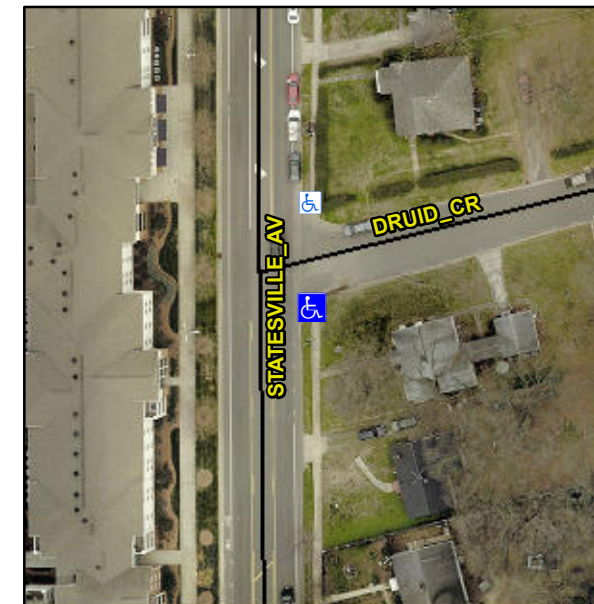
Compliance	Description	Data	Compliance	Description	Data
N/A	Ramp Length (in)	65.0	N/A	Grade Break?	N/A
Yes	Ramp Width (in)	58.5	N/A	Grade Break Slope (%)	0.0
Yes	Ramp Slope (%)	5.8	N/A	Grade Break XSlope (%)	0.0
No	Ramp XSlope (%)	2.7			
N/A	Flare Type LT	N/A	N/A	Flare Type RT	N/A
N/A	Flare Slope LT (%)	N/A	N/A	Flare Slope RT (%)	0.0
N/A	Flare Traversable LT?	N/A	N/A	Flare Traversable RT?	N/A
N/A	Landing Length (in)	0.0	N/A	DWS Provided?	N/A
N/A	Landing Width (in)	0.0	N/A	DWS Contrast?	N/A
N/A	Landing Slope (%)	0.0	N/A	DWS Length (in)	N/A
N/A	Landing X Slope (%)	0.0	N/A	DWS Full Width?	N/A
N/A	Landing Curb? (Y/N)	N/A	N/A	DWS Offset LT (in)	N/A
N/A	Shared Landing?	N/A	N/A	DWS Offset RT (in)	N/A
N/A	Gutter Ponding?	0.0	N/A	Gutter Slope (%)	N/A
N/A	Gutter Lip Ht (in)	0.0	N/A	Gutter X Slope (%)	N/A
N/A	Painted X Walk1?	No		Road Slope (%)	1.4
	X Walk 1 Direction	To N		Road X Slope (%)	0.2
	X Walk 1 Width (in)	N/A		Clear Space?	N/A

X Walk 1 Slope (%)	1.4	N/A	Clear Space to XWalk (in)	N/A
	X Walk 1 X Slope (%)	0.2	N/A	Storm Grate/Utility Hazard?	N/A
N/A	Ramp inside XWalk1?	N/A		Storm Grate/Utility Type	
N/A	Any Obstructions?	N/A			N/A
	Obstruction Type		Yes	Surface Condition? (G/P)	Good
			N/A	Curb Slope (%)	0.6

Possible Solutions:

Remove & Replace Entire Ramp.

R304.5.3
