# Access Compliance Report

## Public Rights-of-Way

### (Curb Ramps)

Intersection ID: N/A	Main Street: GROVER_RD	Cross Street: N/A	Location: NE
ADA ID: B1CE65932FCB	Ramp Type: Perp	Initial Pass/Fail: Fail	Overall Compliance: No
Severity Score: 26.25			
Codes/Mitigation Info/Possible Solution		Field Measurements/Component Compliance

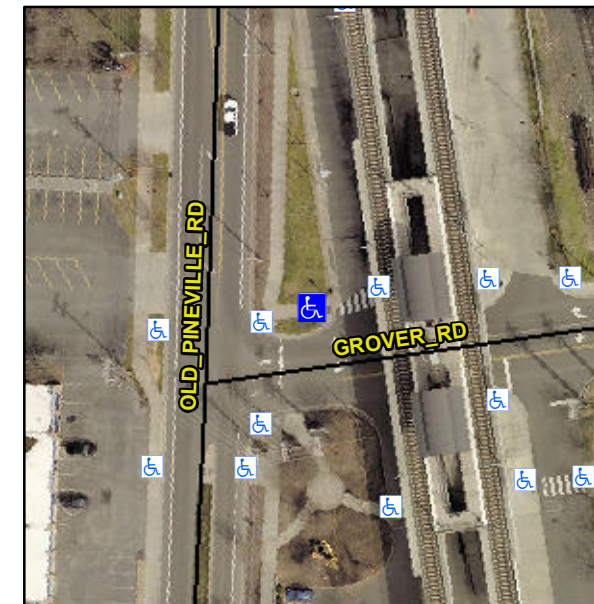
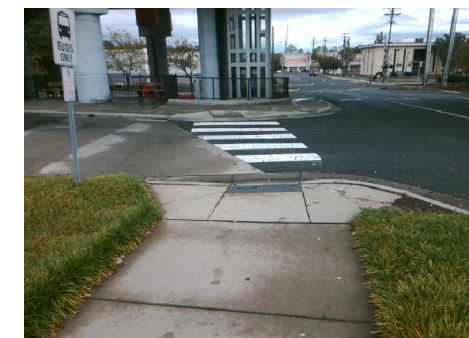
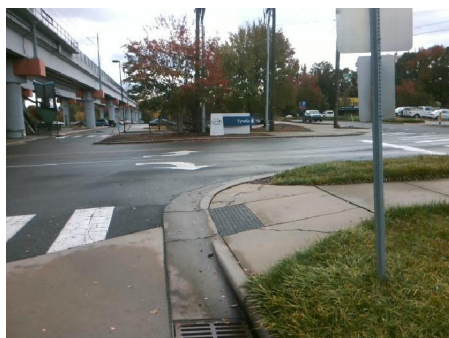
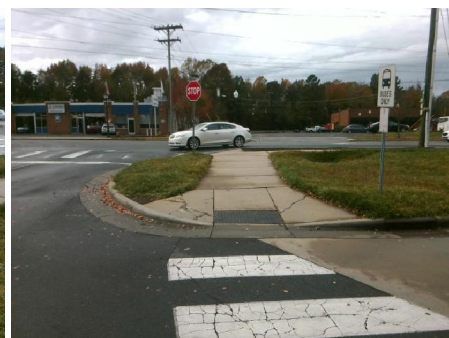
Compliance	Description	Data	Compliance	Description	Data
N/A	Ramp Length (in)	81.0	No	Ramp Slope (%)	13.7
Yes	Ramp Width (in)	48.0	Yes	Ramp XSlope (%)	2.5
N/A	Flare Type LT	N/A	N/A	Flare Type RT	N/A
N/A	Flare Slope LT (%)	N/A	N/A	Flare Slope RT (%)	N/A
N/A	Flare Traversable LT?	N/A	N/A	Flare Traversable RT?	N/A
N/A	Landing Length (in)	N/A	N/A	DWS Provided?	N/A
N/A	Landing Width (in)	N/A	N/A	DWS Contrast?	N/A
N/A	Landing Slope (%)	N/A	N/A	DWS Length (in)	N/A
N/A	Landing X Slope (%)	N/A	N/A	DWS Full Width?	N/A
N/A	Landing Curb? (Y/N)	N/A	N/A	DWS Offset (in)	N/A
N/A	Shared Landing?	N/A			
N/A	Gutter Ponding?	N/A	N/A	Gutter Slope (%)	N/A
N/A	Gutter Lip Ht (in)	N/A	N/A	Gutter X Slope (%)	N/A
N/A	Painted X Walk1?	Yes	N/A	Painted X Walk2?	N/A
	X Walk 1 Direction	To E		X Walk 2 Direction	N/A
N/A	X Walk 1 Width (in)	120.0	N/A	X Walk 2 Width (in)	N/A
	X Walk 1 Slope (%)	0.1		X Walk 2 Slope (%)	N/A
	X Walk 1 X Slope (%)	3.0		X Walk 2 X Slope (%)	N/A

N/A	Ramp inside XWalk1?	Yes	N/A	Ramp inside XWalk2?	N/A
	Road Slope (%)	N/A	N/A	Clear Space?	N/A
	Road X Slope (%)	N/A	N/A	Clear Space to XWalk (in)	N/A
N/A	Any Obstructions?	N/A	N/A	Storm Grate/Utility Hazard?	N/A
	Obstruction Type			Storm Grate/Utility Type	
		N/A			N/A
		Yes		Surface Condition? (G/P)	Good

Possible Solutions:

**Remove & Replace Entire Ramp.**

**R304.2.2**
