Access Compliance Report

Public Rights-of-Way

(Curb Ramps)

Intersection ID: 28182	Main Street: FIELDCROFT_DR	Cross Street: WOODEND_CT	Location: NW
ADA ID: B1DB96C5C5ED	Ramp Type: BlendTrans2	Initial Pass/Fail: Fail	Overall Compliance: No
Severity Score: 36.25			
Codes/Mitigation Info/Possible Solution		Field Measurements/Component Compliance

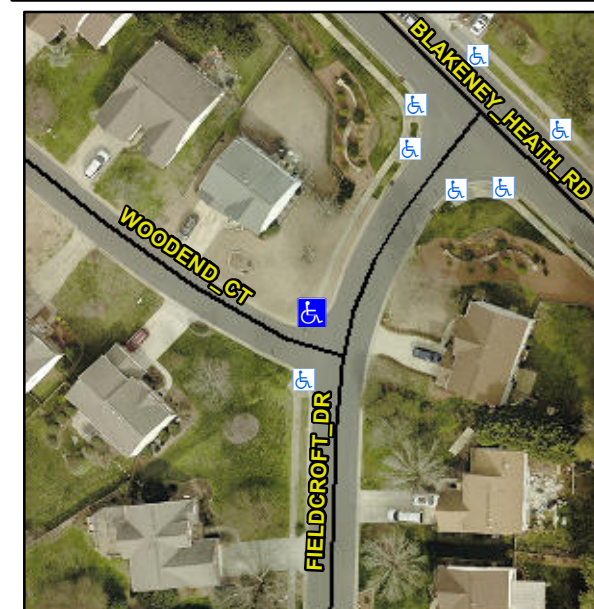
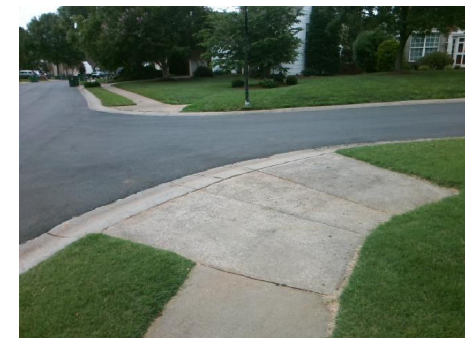
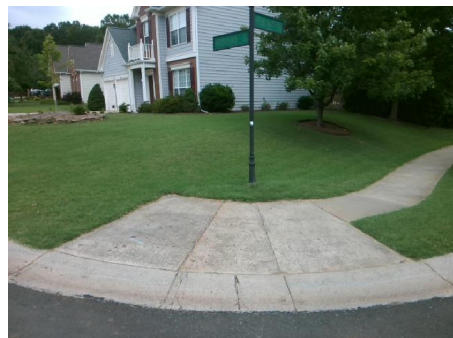
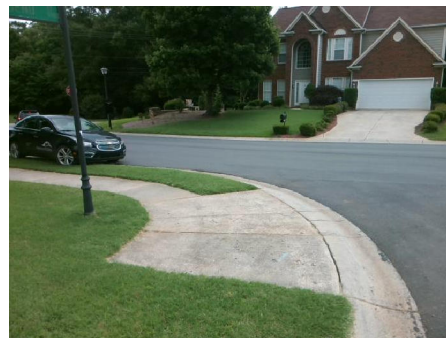
Not Found, R304.5.1, R304.5.3

Compliance	Description	Data	Compliance	Description	Data
N/A	Ramp Length (in)	95.0	Yes	BlendTrans Slope (%)	3.8
No	Ramp Width (in)	25.0	No	BlendTrans XSlope (%)	4.0
N/A	Flare Type LT	N/A	N/A	Flare Type RT	N/A
N/A	Flare Slope LT (%)	N/A	N/A	Flare Slope RT (%)	N/A
N/A	Flare Traversable LT?	N/A	N/A	Flare Traversable RT?	N/A
N/A	Landing Length (in)	N/A	N/A	DWS Provided?	N/A
N/A	Landing Width (in)	N/A	N/A	DWS Contrast?	N/A
N/A	Landing Slope (%)	N/A	N/A	DWS Length (in)	N/A
N/A	Landing X Slope (%)	N/A	N/A	DWS Full Width?	N/A
N/A	Landing Curb? (Y/N)	N/A	N/A	DWS Offset (in)	N/A
N/A	Shared Landing?	N/A			
N/A	Gutter Ponding?	N/A	N/A	Gutter Slope (%)	N/A
N/A	Gutter Lip Ht (in)	N/A	N/A	Gutter X Slope (%)	N/A
N/A	Painted X Walk1?	No	N/A	Painted X Walk2?	No
	X Walk 1 Direction	To S		X Walk 2 Direction	To E
	X Walk 1 Width (in)	N/A		X Walk 2 Width (in)	N/A
	X Walk 1 Slope (%)	1.9		X Walk 2 Slope (%)	0.9
	X Walk 1 X Slope (%)	1.7		X Walk 2 X Slope (%)	2.8

N/A	Ramp inside XWalk1?	N/A	N/A	Ramp inside XWalk2?	N/A
	Road Slope (%)	1.8		Clear Space?	N/A
	Road X Slope (%)	2.5	N/A	Clear Space to XWalk (in)	N/A
N/A	Any Obstructions?	N/A	N/A	Storm Grate/Utility Hazard?	N/A
	Obstruction Type			Storm Grate/Utility Type	
		N/A			N/A
		Yes		Surface Condition? (G/P)	Good
		No		Curb Slope (%)	17.1

Possible Solutions:

Remove & Replace Curb Ramp With Two New Directional Ramps or Equivalent.
