Access Compliance Report Public Rights-of-Way (Curb Ramps)

Intersection ID: N/A Main Street: SPRINGWOOD_ESTATE_DR Cross Street: SAGMORE_HILL_DR Location: NE

ADA ID: B1DF45093D44 Ramp Type: Perp Initial Pass/Fail: Fail Overall Compliance: No Severity Score: 33.75

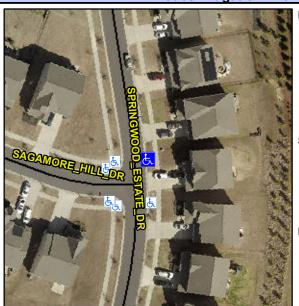
/Possible Solution			Field Measurements/Component Compliance					
Possible Solutions:			Compliance Description		Data	Comp	liance	Description
Remove & Replace Enti	re Ram	p.	N/A	Ramp Length (in)	95.0	Yes	Ramp	Slope (%)
			No	Ramp Width (in)	47.0	No	Ramp	XSlope (%)
			N/A	Flare Type LT	N/A	N/A	Flare	Type RT
			N/A	Flare Slope LT (%)	N/A	N/A	Flare	Slope RT (%)
			N/A	Flare Traversable LT?	N/A	N/A	Flare	Traversable RT?
			N/A	Landing Length (in)	N/A	N/A	DWS	Provided?
Surveyor Notes:			N/A	Landing Width (in)	N/A	N/A	DWS	Contrast?
N/A			N/A	Landing Slope (%)	N/A	N/A	DWS	Length (in)
			N/A	Landing X Slope (%)	N/A	N/A	DWS	Full Width?
			N/A	Landing Curb? (Y/N)	N/A	N/A	DWS	Offset (in)
			N/A	Shared Landing?	N/A			
PROW/ADA:			N/A	Gutter Ponding?	N/A	N/A	Gutter	Slope (%)
Not Found, R304.5.1, R304.5.3			N/A	Gutter Lip Ht (in)	N/A	N/A	Gutter	X Slope (%)
			N/A	Painted X Walk1?	No	N/A	Painte	ed X Walk2?
				X Walk 1 Direction	To W		X Wal	k 2 Direction

N/A	X Walk 1 Width (in)	N/A	N/A	X Wal	k 2 Width (in)
				X Walk 1 Slope (%)	1.8		X Wal	k 2 Slope (%)
				X Walk 1 X Slope (%)	4.9		X Wal	k 2 X Slope (%)
			N/A	Ramp inside XWalk1?	N/A	N/A	Ramp	inside XWalk2?
				Road Slope (%)	N/A	N/A	Clear	Space?
				Road X Slope (%)	N/A	N/A	Clear	Space to XWalk (in)
			N/A	Any Obstructions?	N/A	N/A	Storm	Grate/Utility Hazard?
Total Cost:	\$	1850.00		Obstruction Type		l	Storm	Grate/Utility Type
